The chemical and microbiological assessment of water and soil samples

FINDING THE BEST FITTING SOLUTIONS FOR WASTEWATER MANAGEMENT IN VILLAGES

VillageWaters Project
Research about Wastewater Treatment Systems

Report number 1

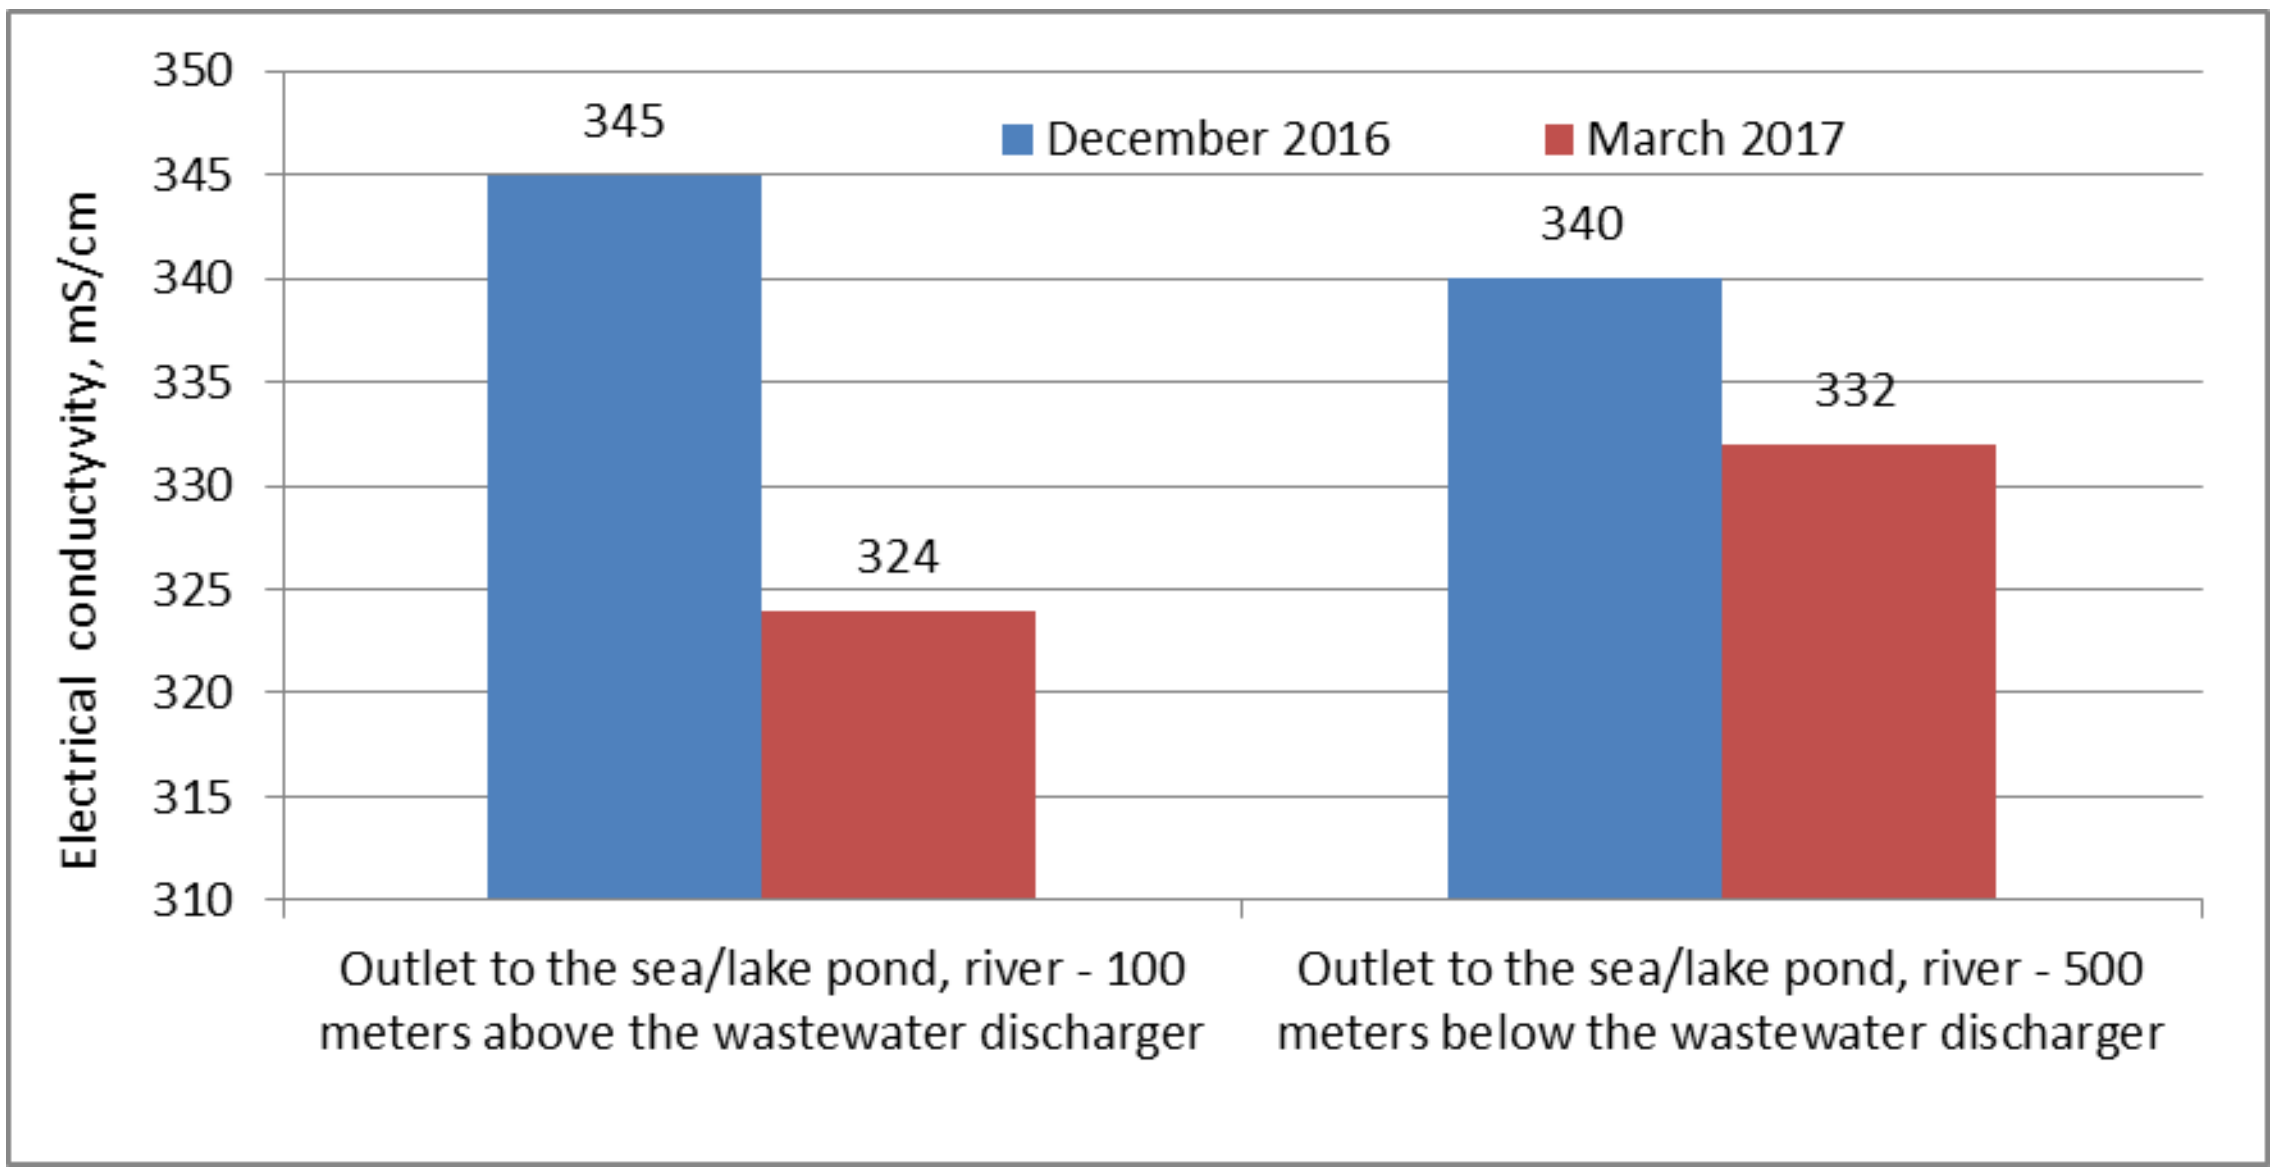
Figure 3.1.1.2. Electrical conductivity measurement results

The electrical conductivity value in December was higher than that in March. The electrical conductivity value in the Punsu river in December was higher 100 meters before the wastewater discharger, while in March it was higher 500 meters after the wastewater discharger. This shows that released wastewater can affect the Punsu river's water quality during the warm period of the year.

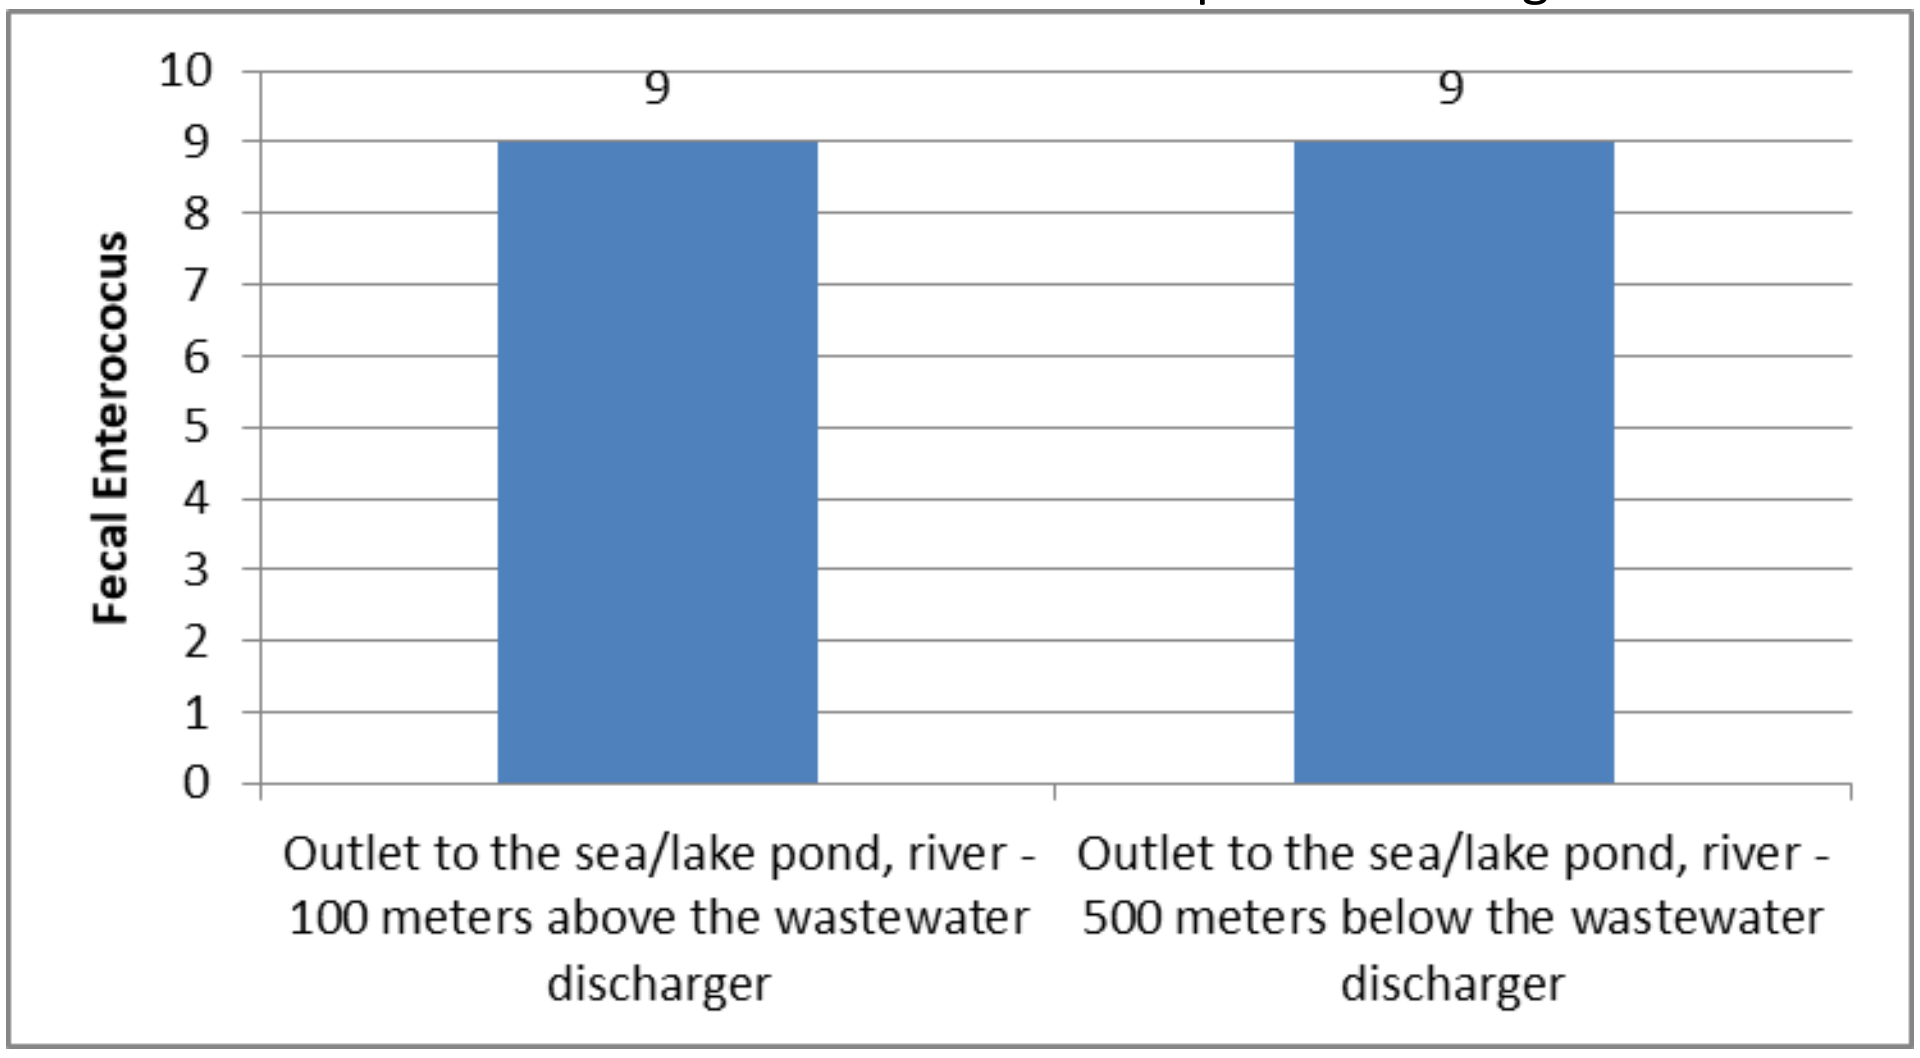
Figure 3.1.1.3. Fecal Enterococcus measurement results

The Fecal Enterococcus value in the Punsu river both 100 meters before and 500 meters after the wastewater discharger was the same. Escerichia coli bacterial measurement results are provided in Figure 3.2.1.4.

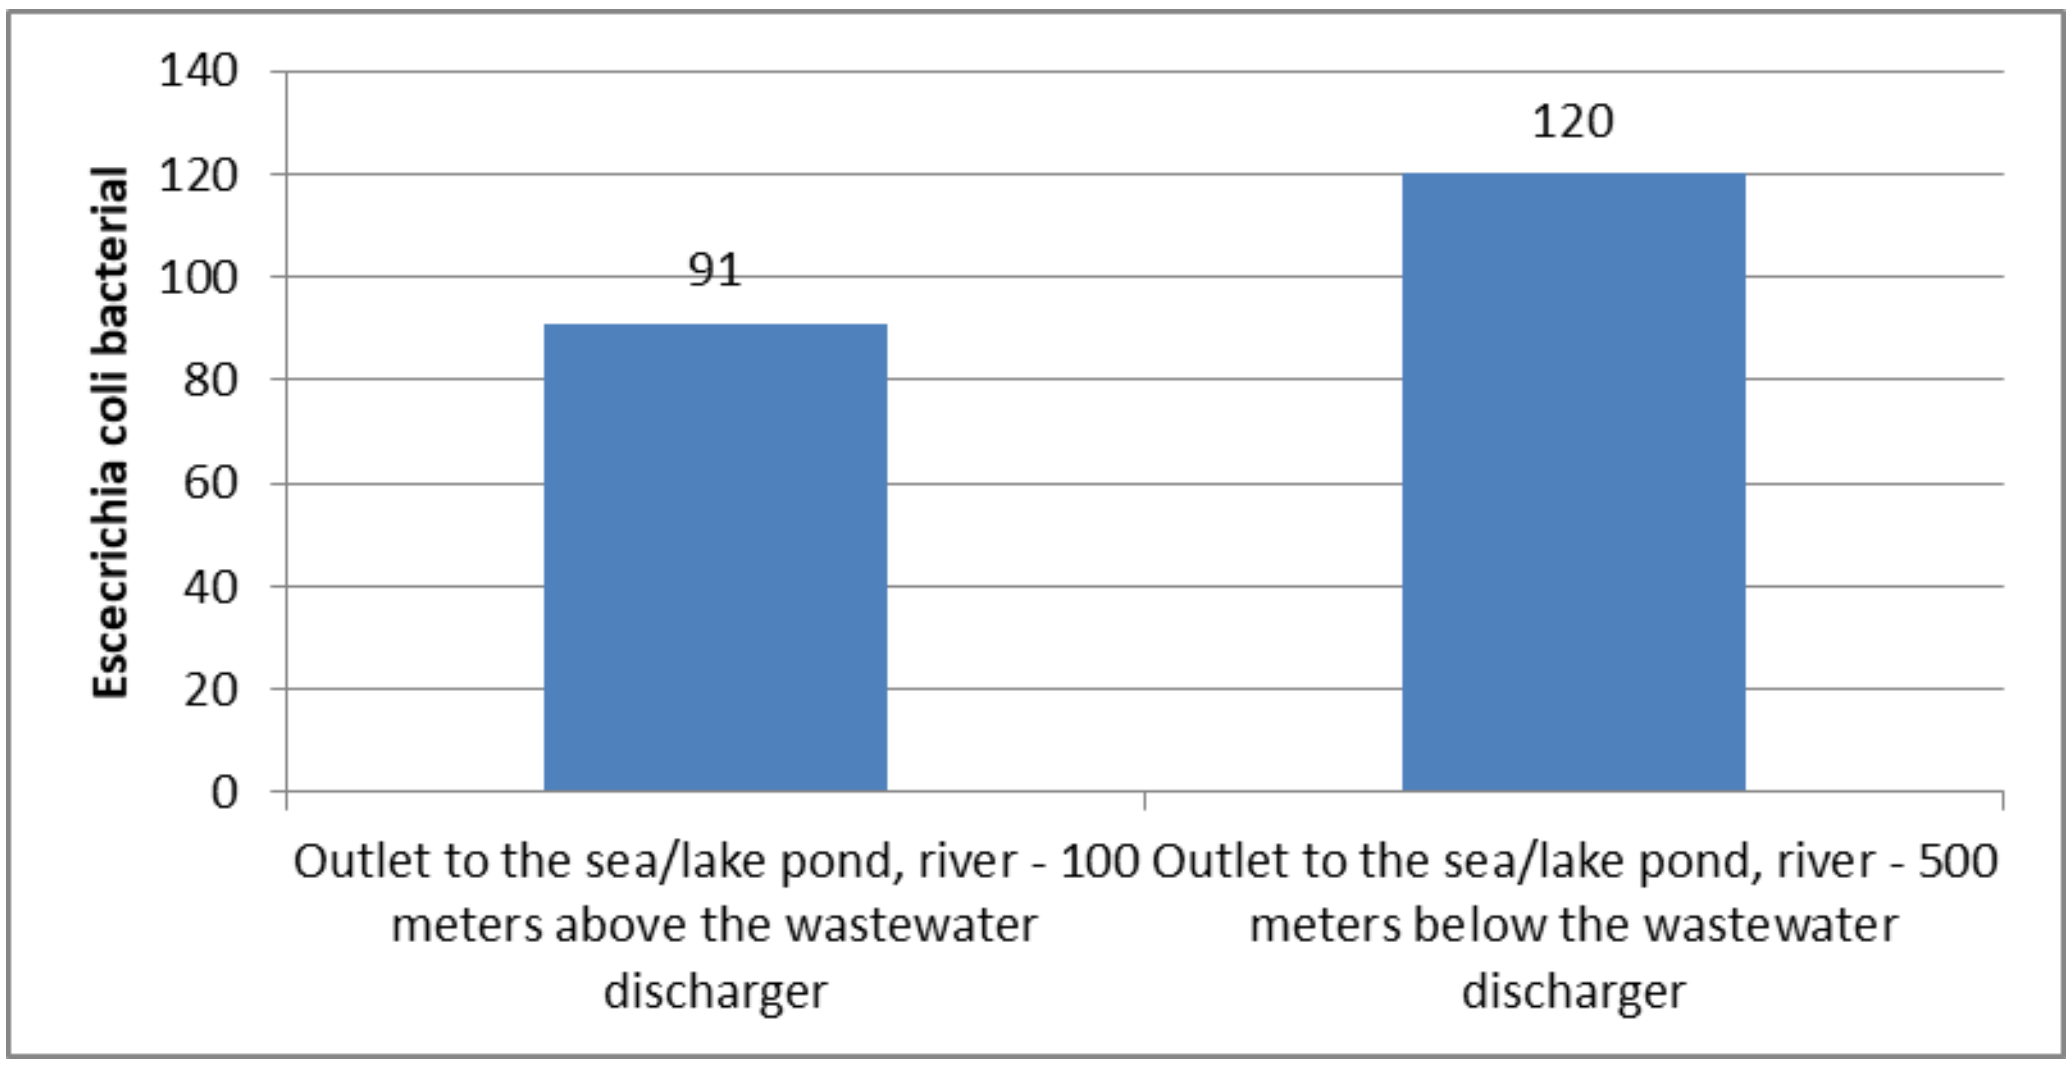
Figure 3.1.1.4. Escerichia coli bacterial measurement results

The found Escerichia coli bacterial value in the Punsu river was higher 500 meters after the wastewater discharger than 100 meters before the wastewater discharger. This shows that released wastewater can affect the Punsu river's water quality.

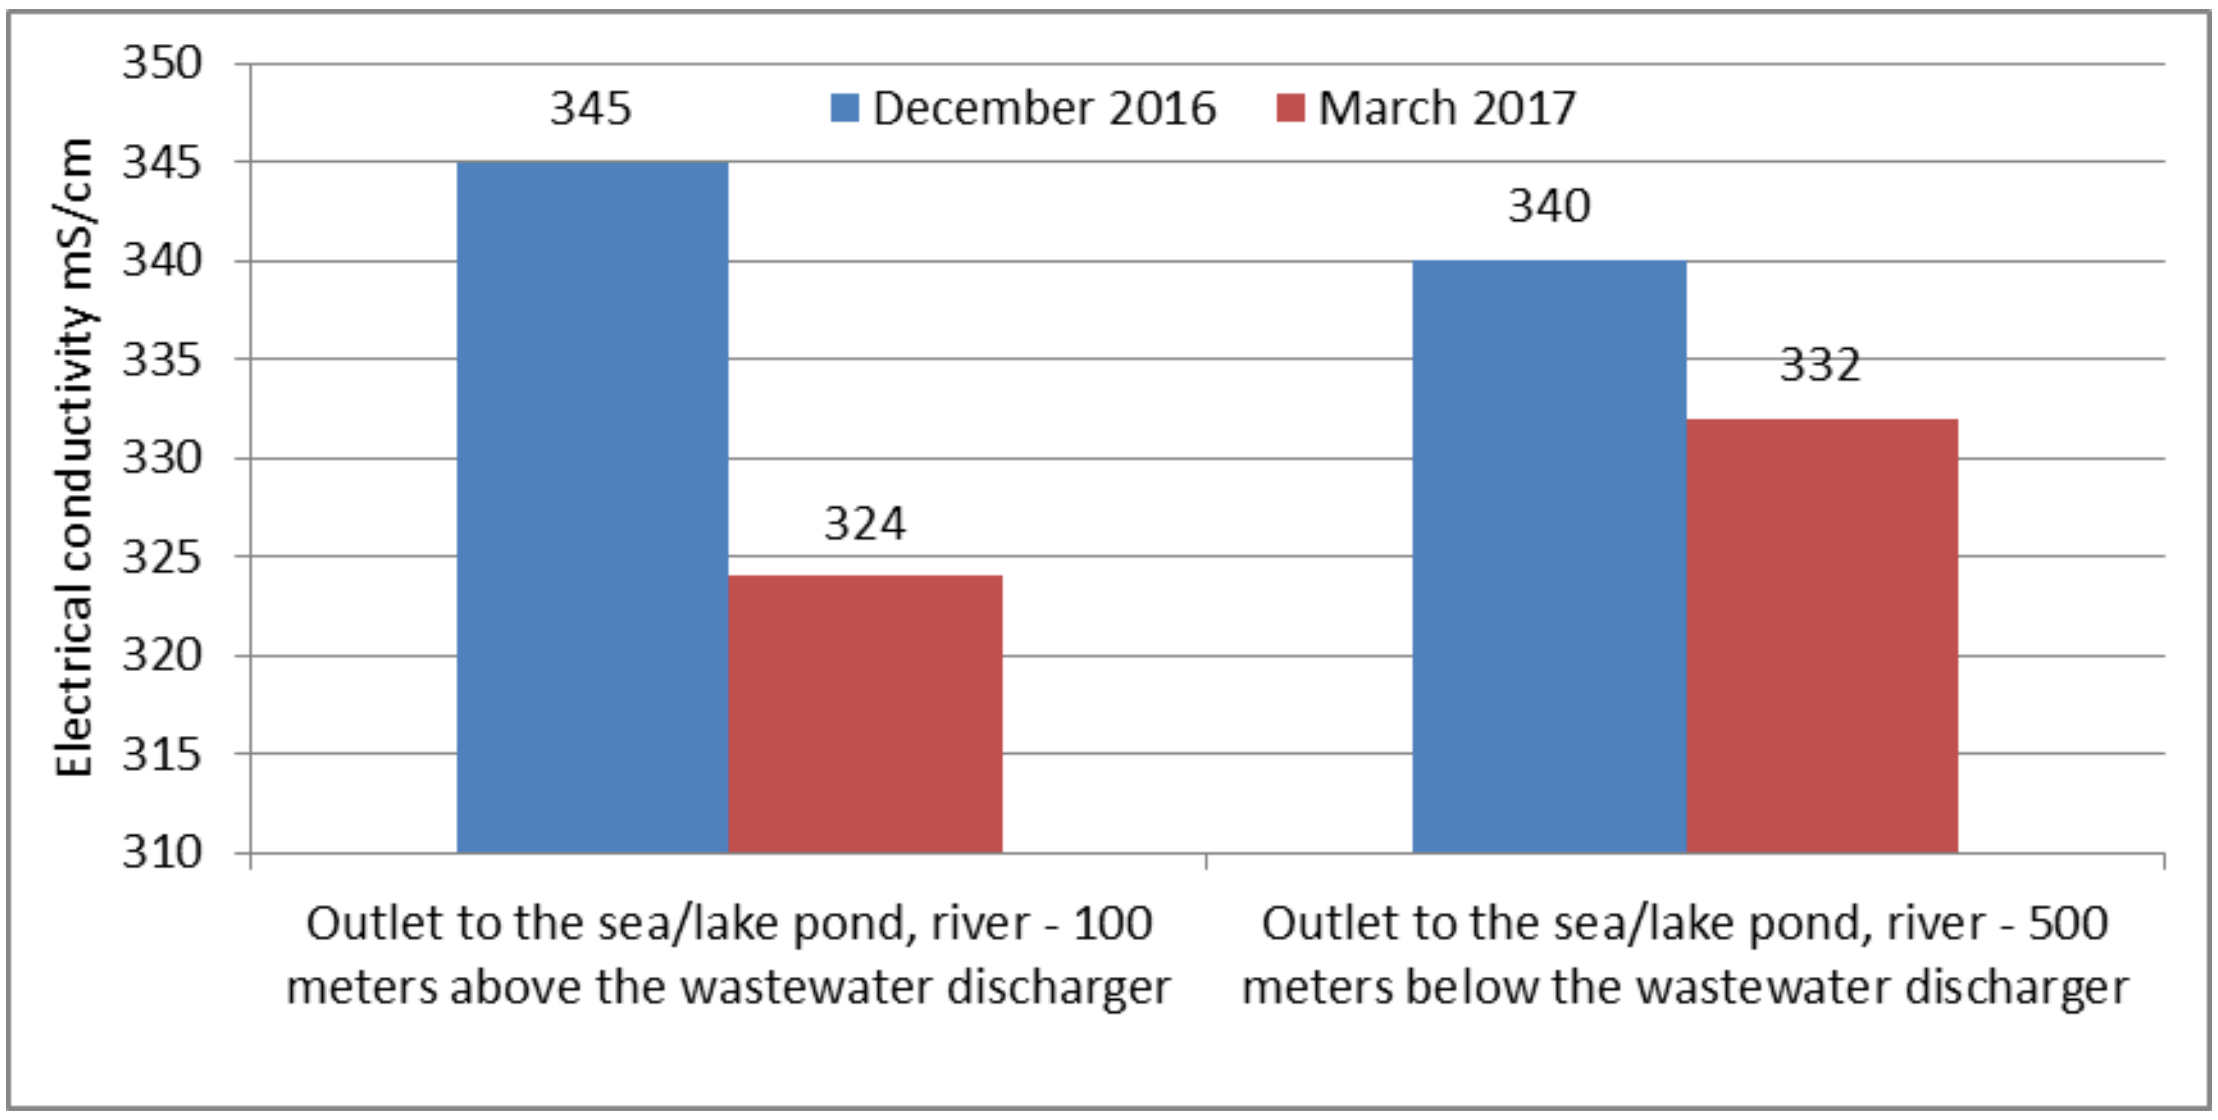
Figure 3.1.2.2. Electrical conductivity measurement results

The electrical conductivity value in December was higher than that in March. The electrical conductivity value in the Punsu river in December was higher 100 meters before the wastewater discharger, while in March it was higher 500 meters after the wastewater discharger. This shows that released wastewater can affect the Punsu river's water quality during the warm period of the year. Fecal Enterococcus measurement results are provided in Figure 3.1.2.3.

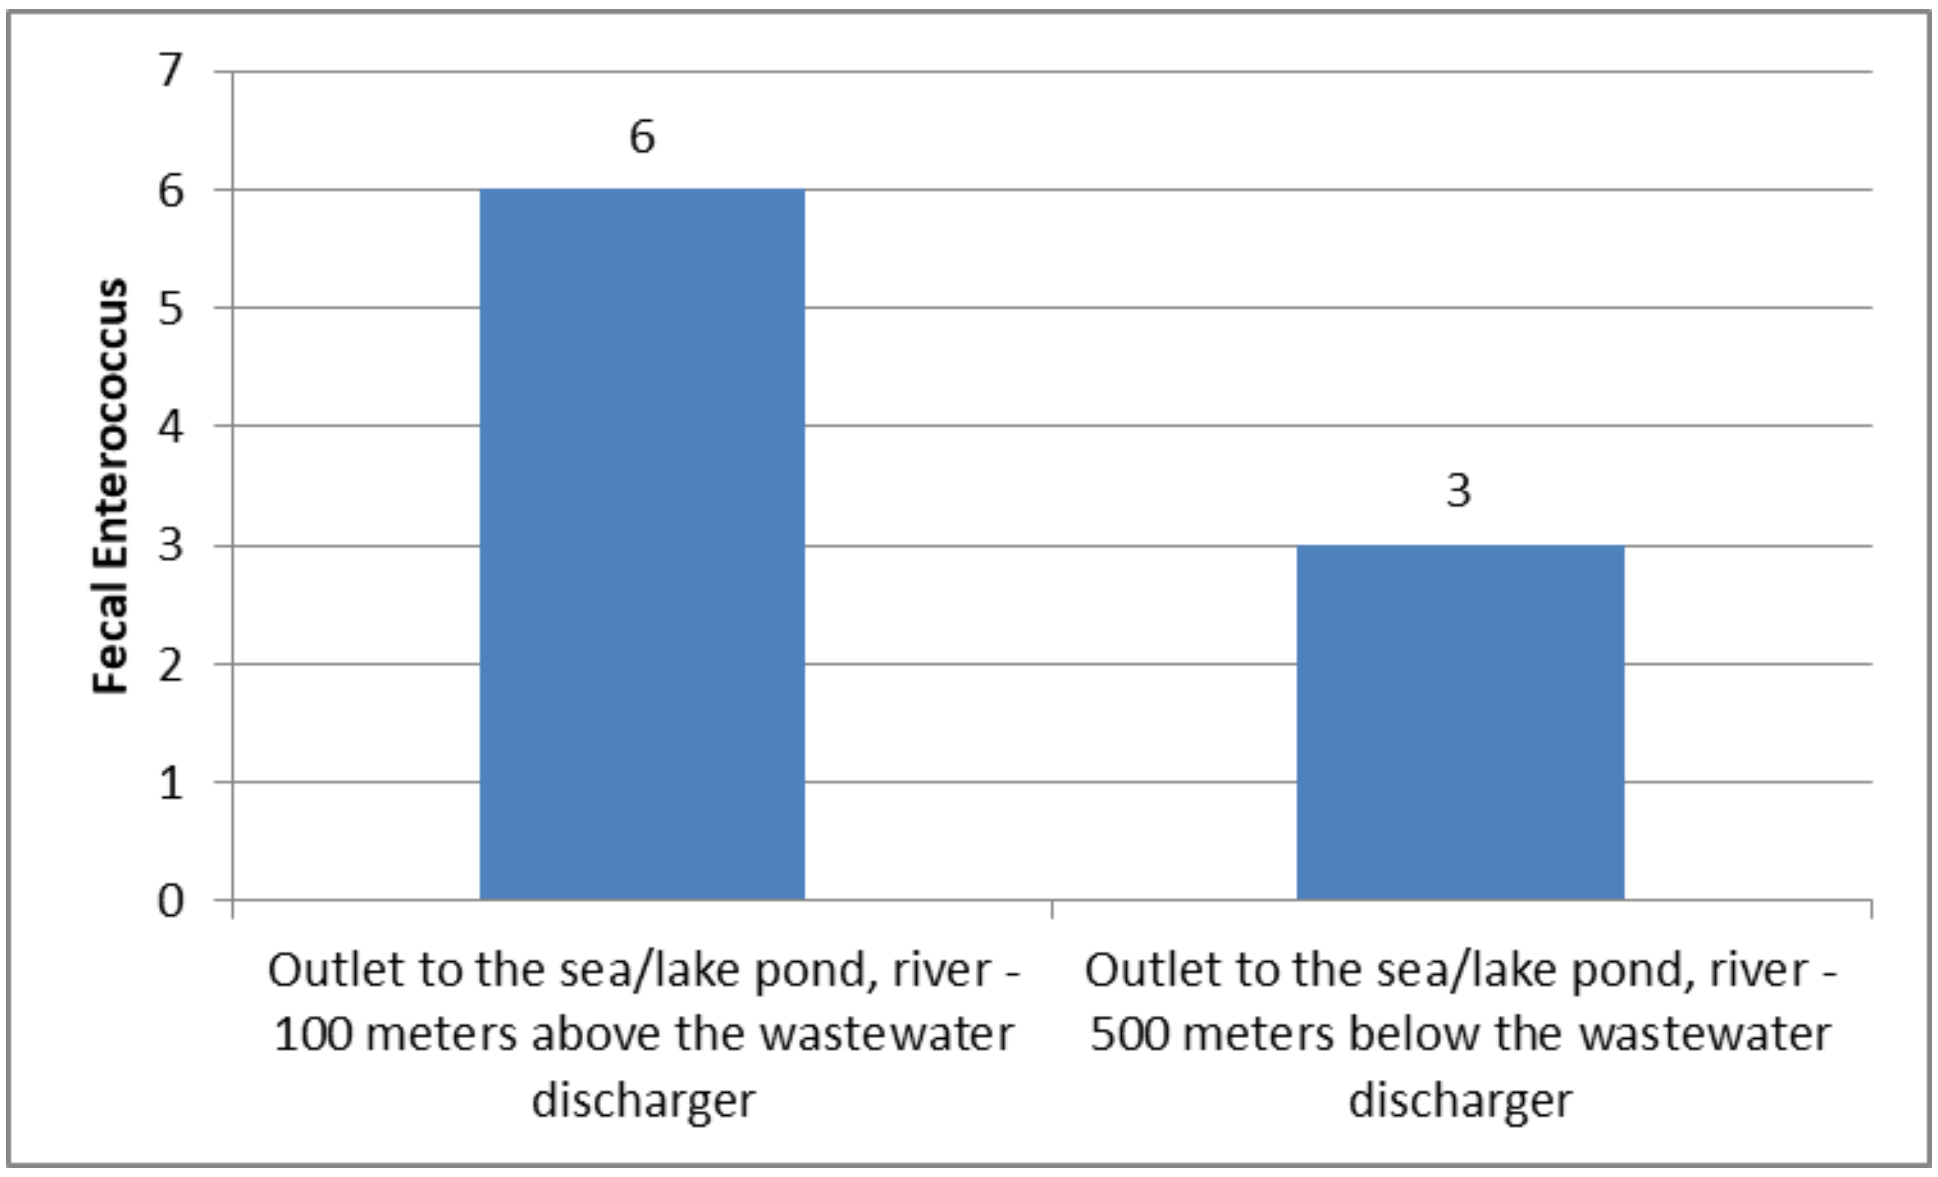
Figure 3.1.2.3. Fecal Enterococcus measurement results

The Fecal Enterococcus value in the Punsu river both 100 meters before and 500 meters after the wastewater discharger was the same. Escerichia coli bacterial measurement results are provided in Figure 3.1.2.4.

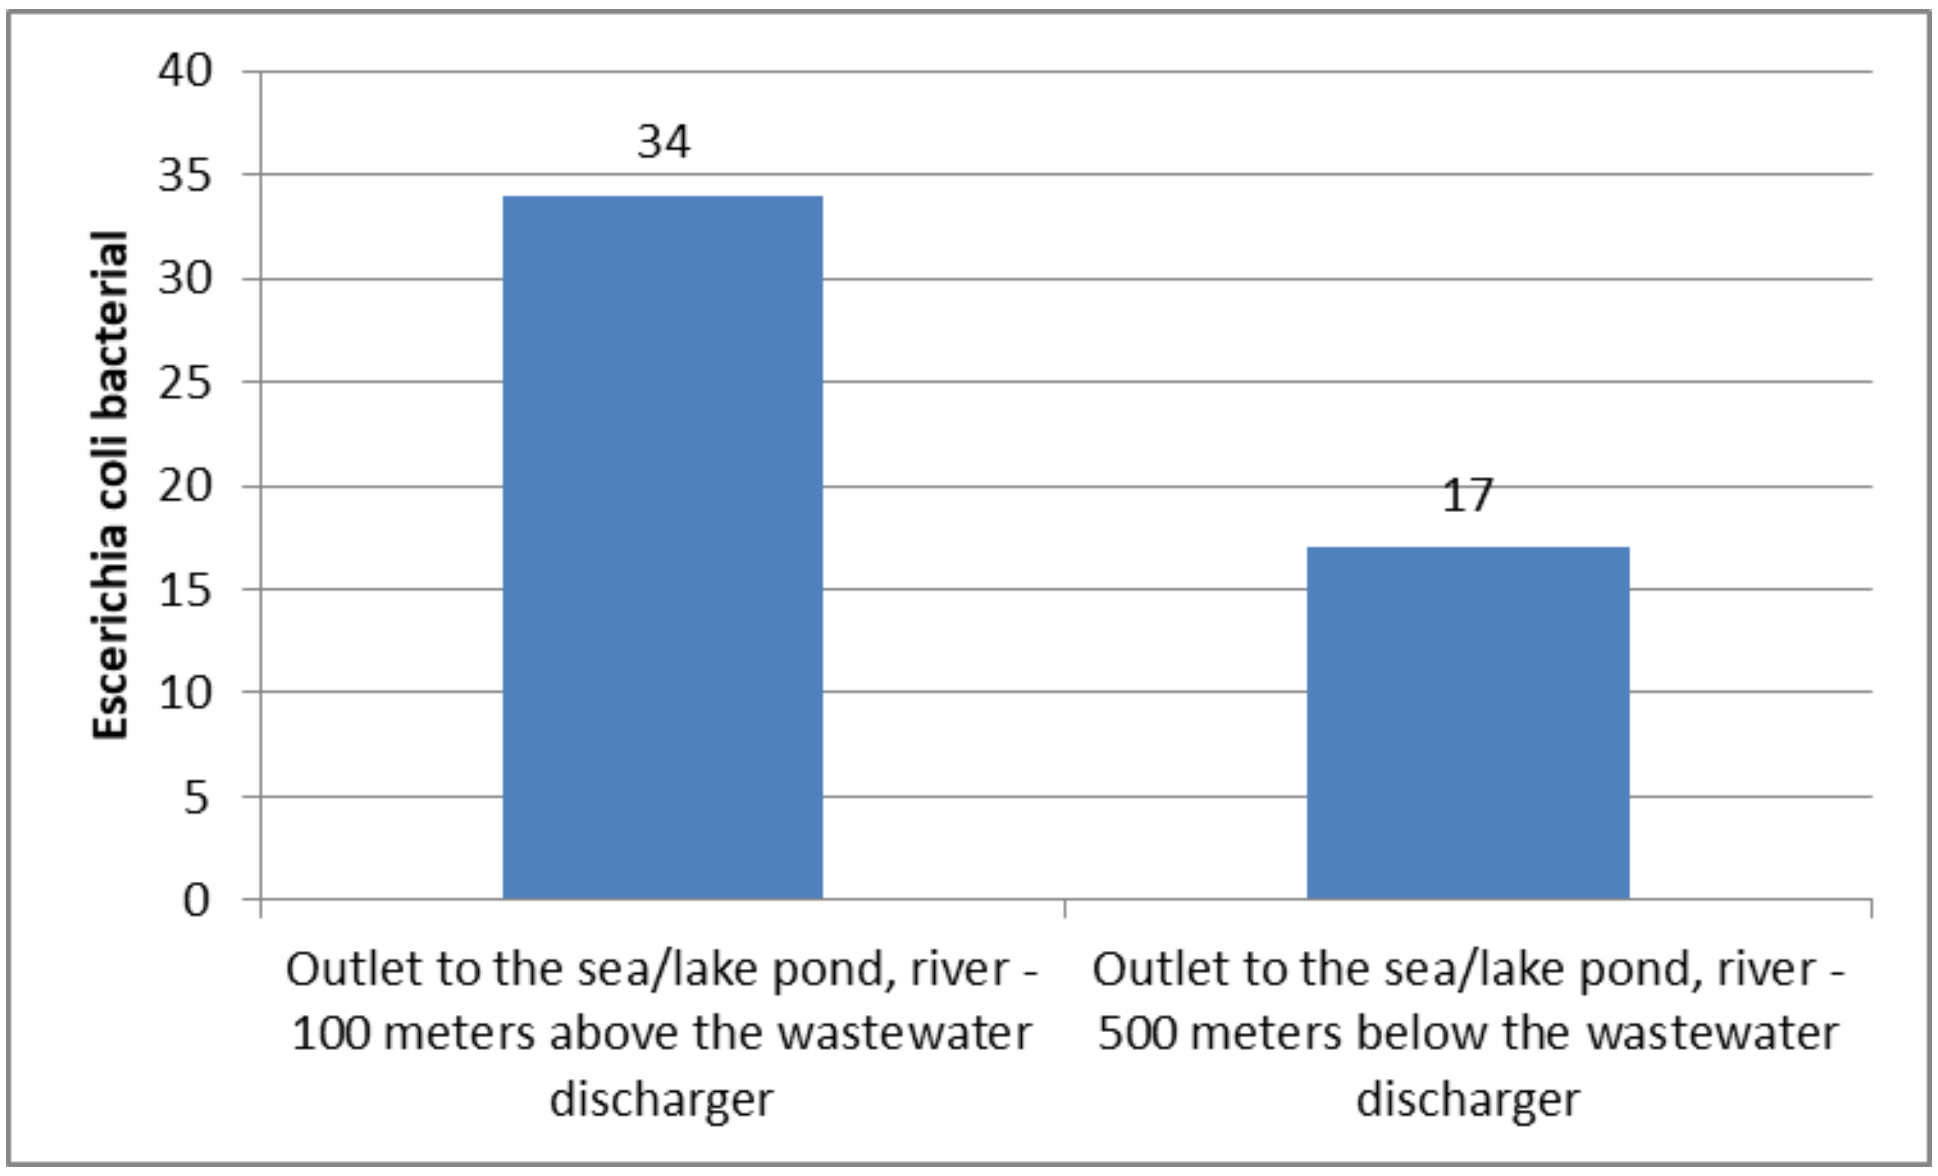
Figure 3.1.2.4. Escerichia coli bacterial measurement results

The found Escerichia coli bacterial value in the Punsu river was higher 100 meters before the wastewater discharger than 500 meters after the wastewater discharger. This shows that released wastewater does not affect the Punsu river's water quality.

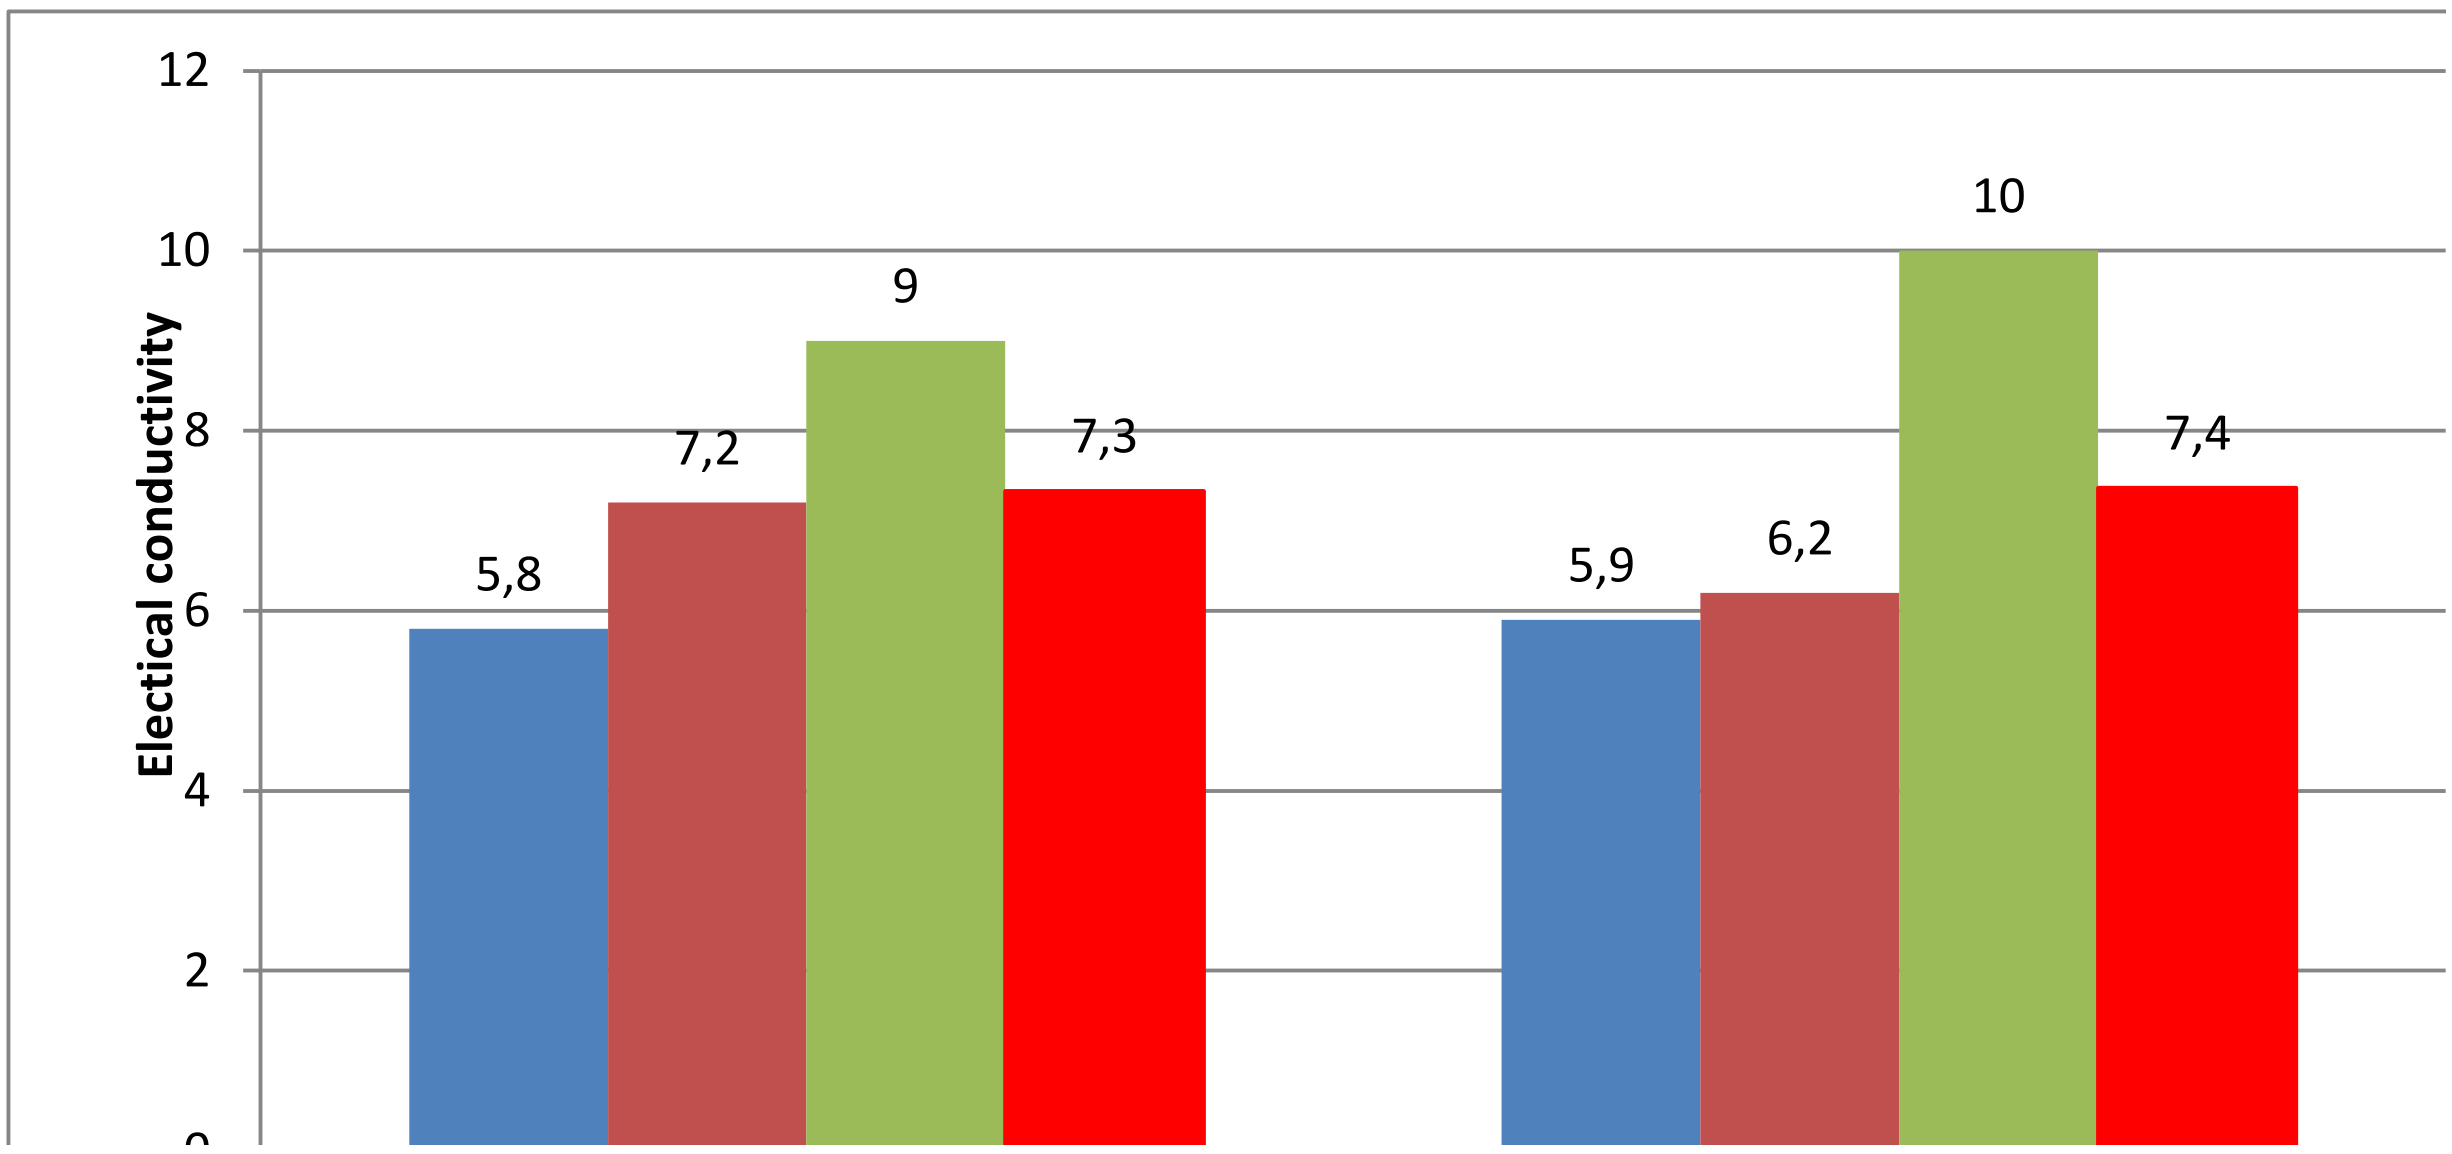
Figure 3. 2.1.2. Electrical conductivity measurement results

The electrical conductivity value increases every month. In every month of the assessment, the measured electrical conductivity value in the Gennarbyträsk Lake was higher 500 meters after the wastewater discharger, except for the month of July. The increase in values doesn't really tell about wastewater effects, but just normal variation. Fecal Enterococcus measurement results provided in Figure 3.2.1.3.

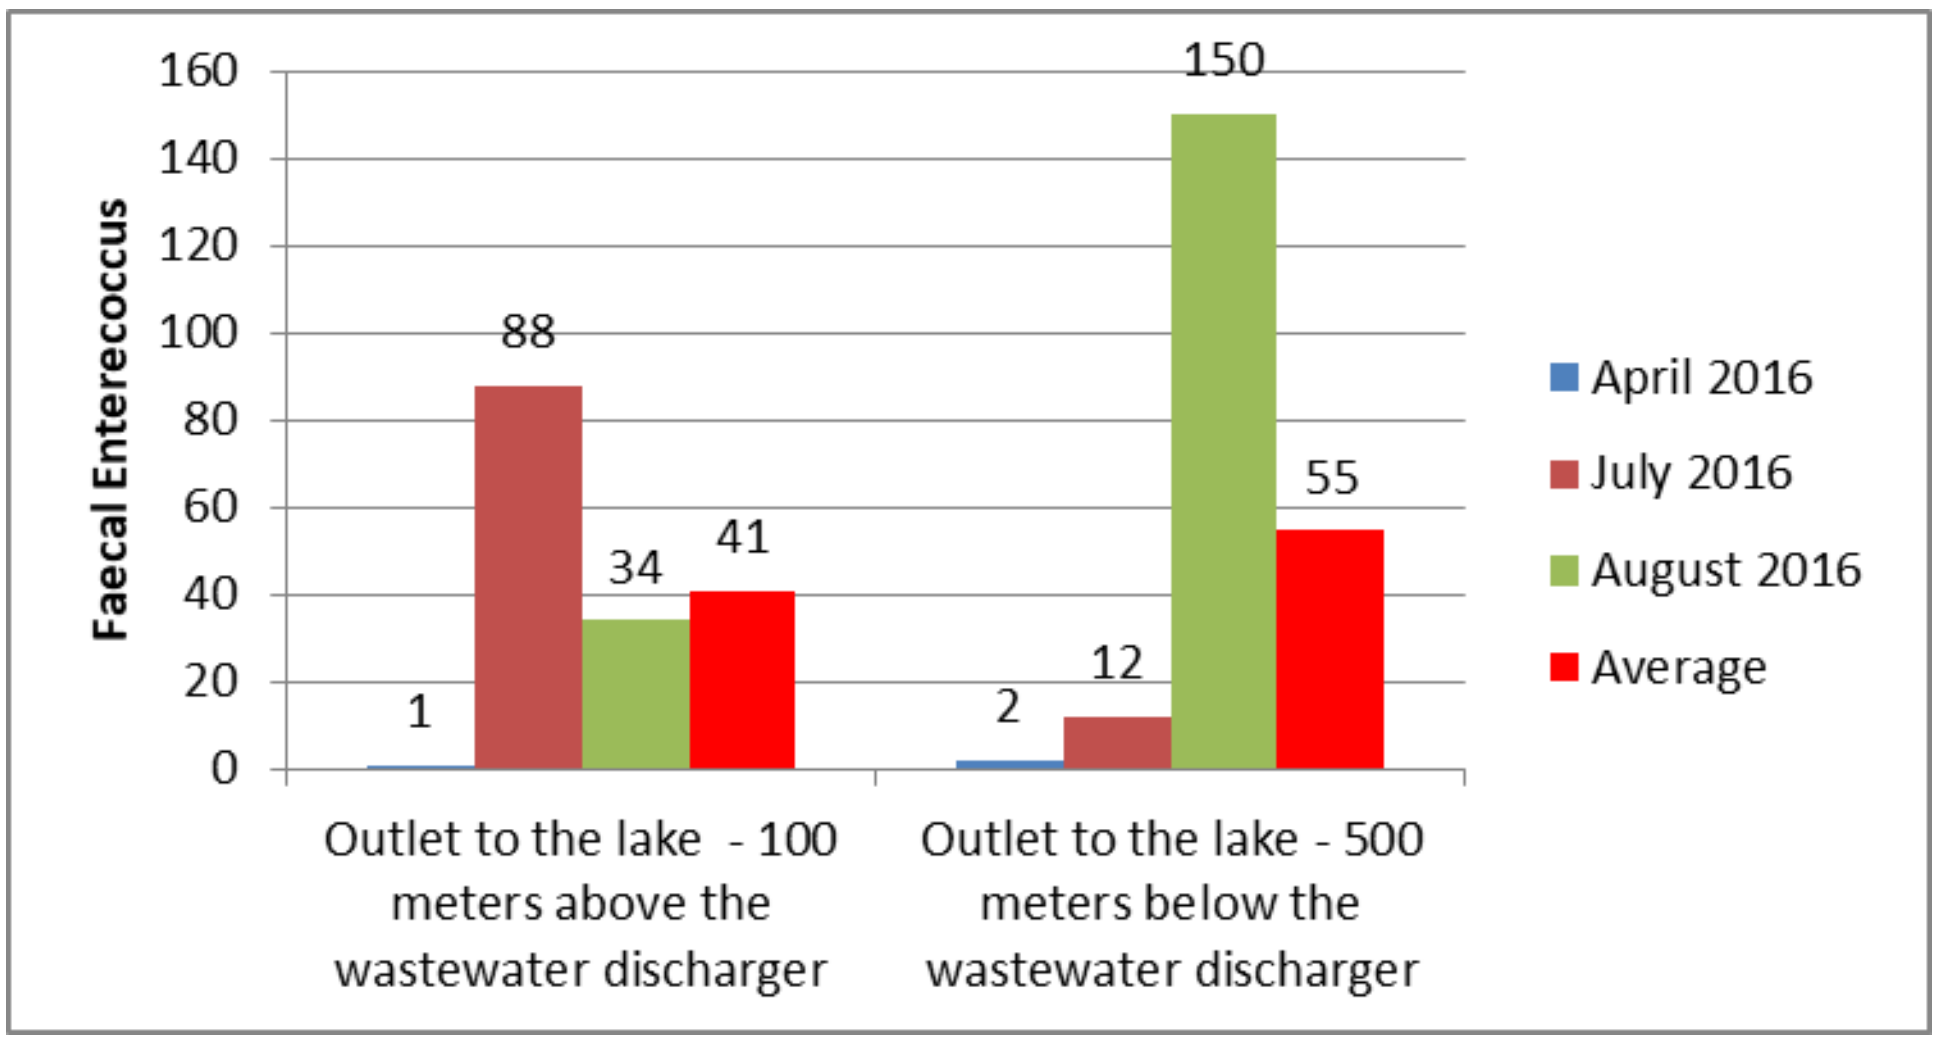
Figure 3. 2.1.3. Fecal Enterococcus measurement results

The Fecal Enterococcus value in the Gennarbyträsk Lake was higher 500 meters after the wastewater discharger, except for the month of July. This shows that released wastewater can affect the Gennarbyträsk lake water quality. Escerichia coli bacterial measurement results are provided in Figure 3.2.1.4.

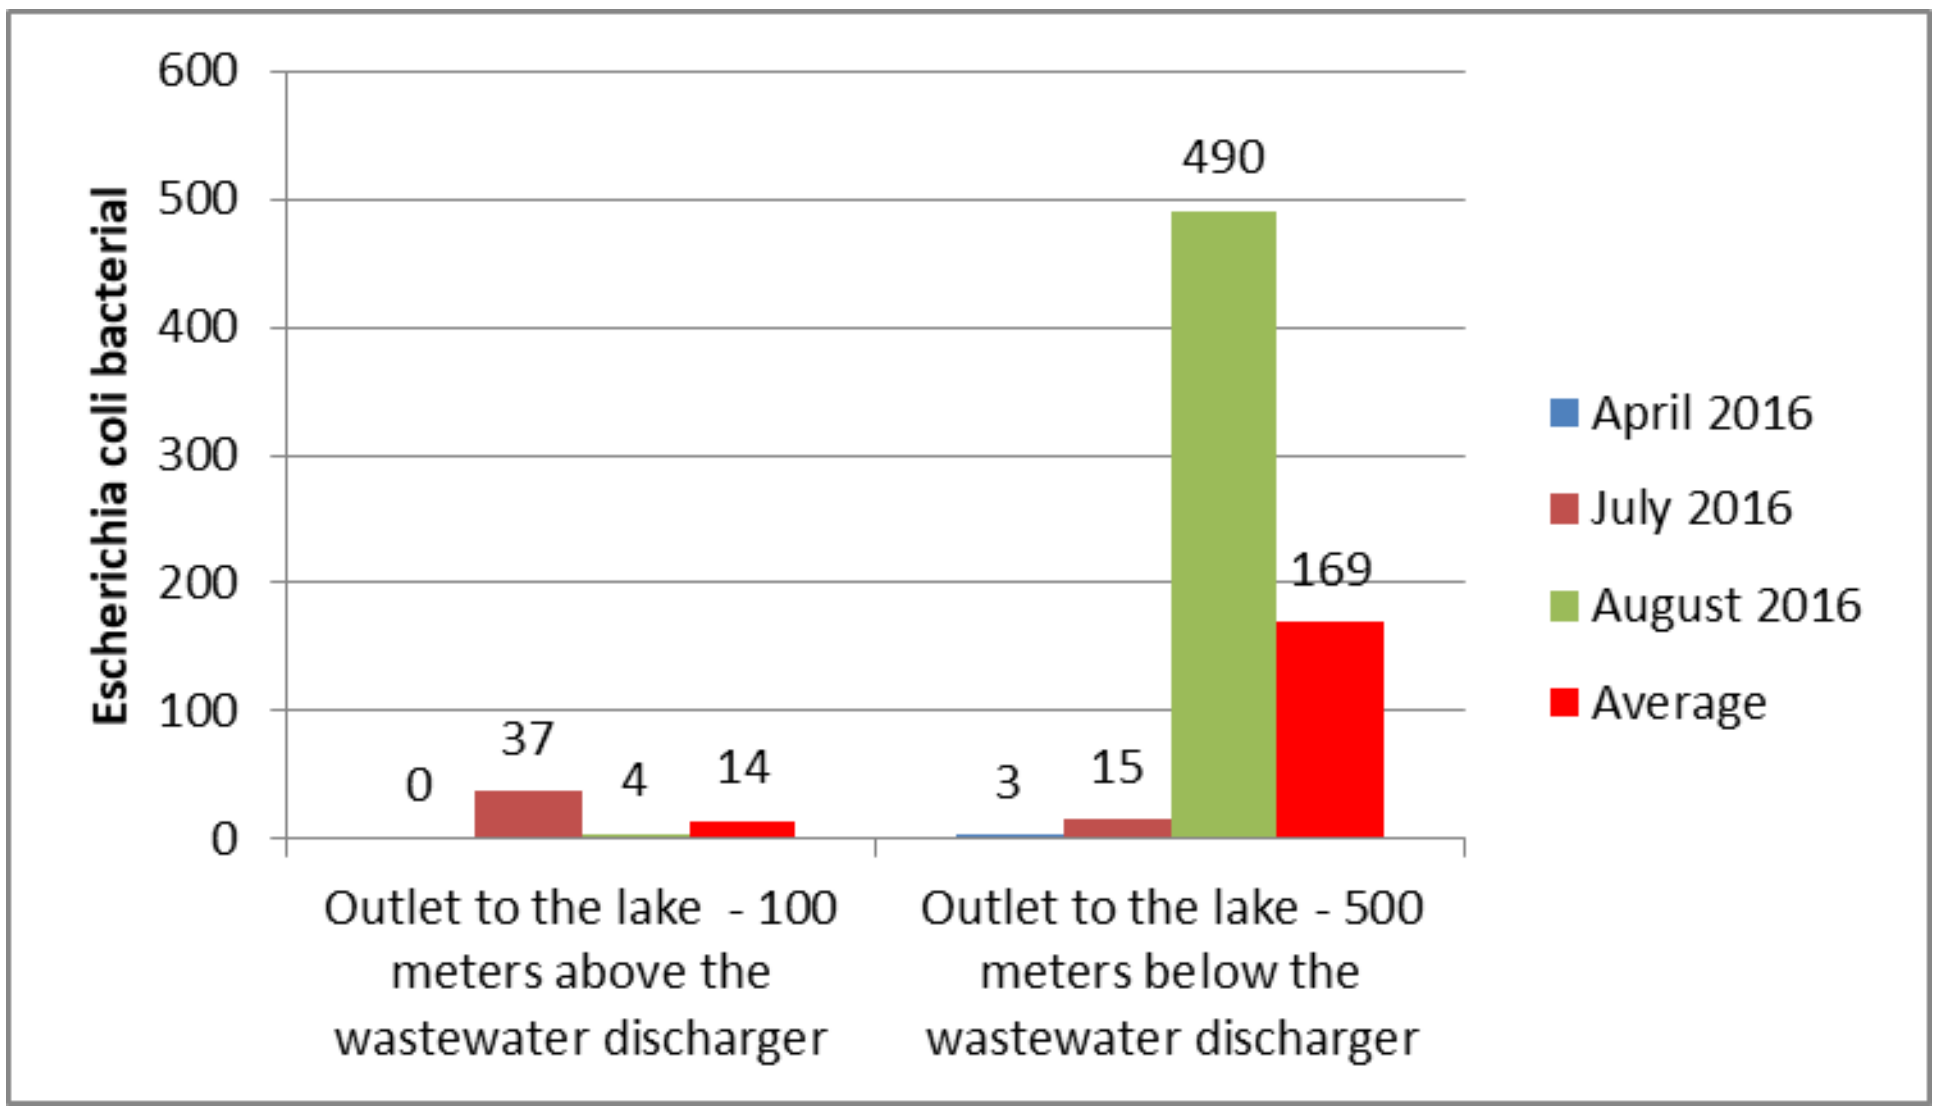
3.2.1.4.Figure. Escerichia coli bacterial measurement results

Escerichia coli bacterial value in the Gennarbyträsk lake was higher 500 meters after the wastewater discharger, except for the month of July. This shows that released wastewater can affect the Gennarbyträsk lake water quality.
