The chemical and microbiological assessment of water and soil samples

FINDING THE BEST FITTING SOLUTIONS FOR WASTEWATER MANAGEMENT IN VILLAGES

VillageWaters Project
Research about Wastewater Treatment Systems

Report number 1

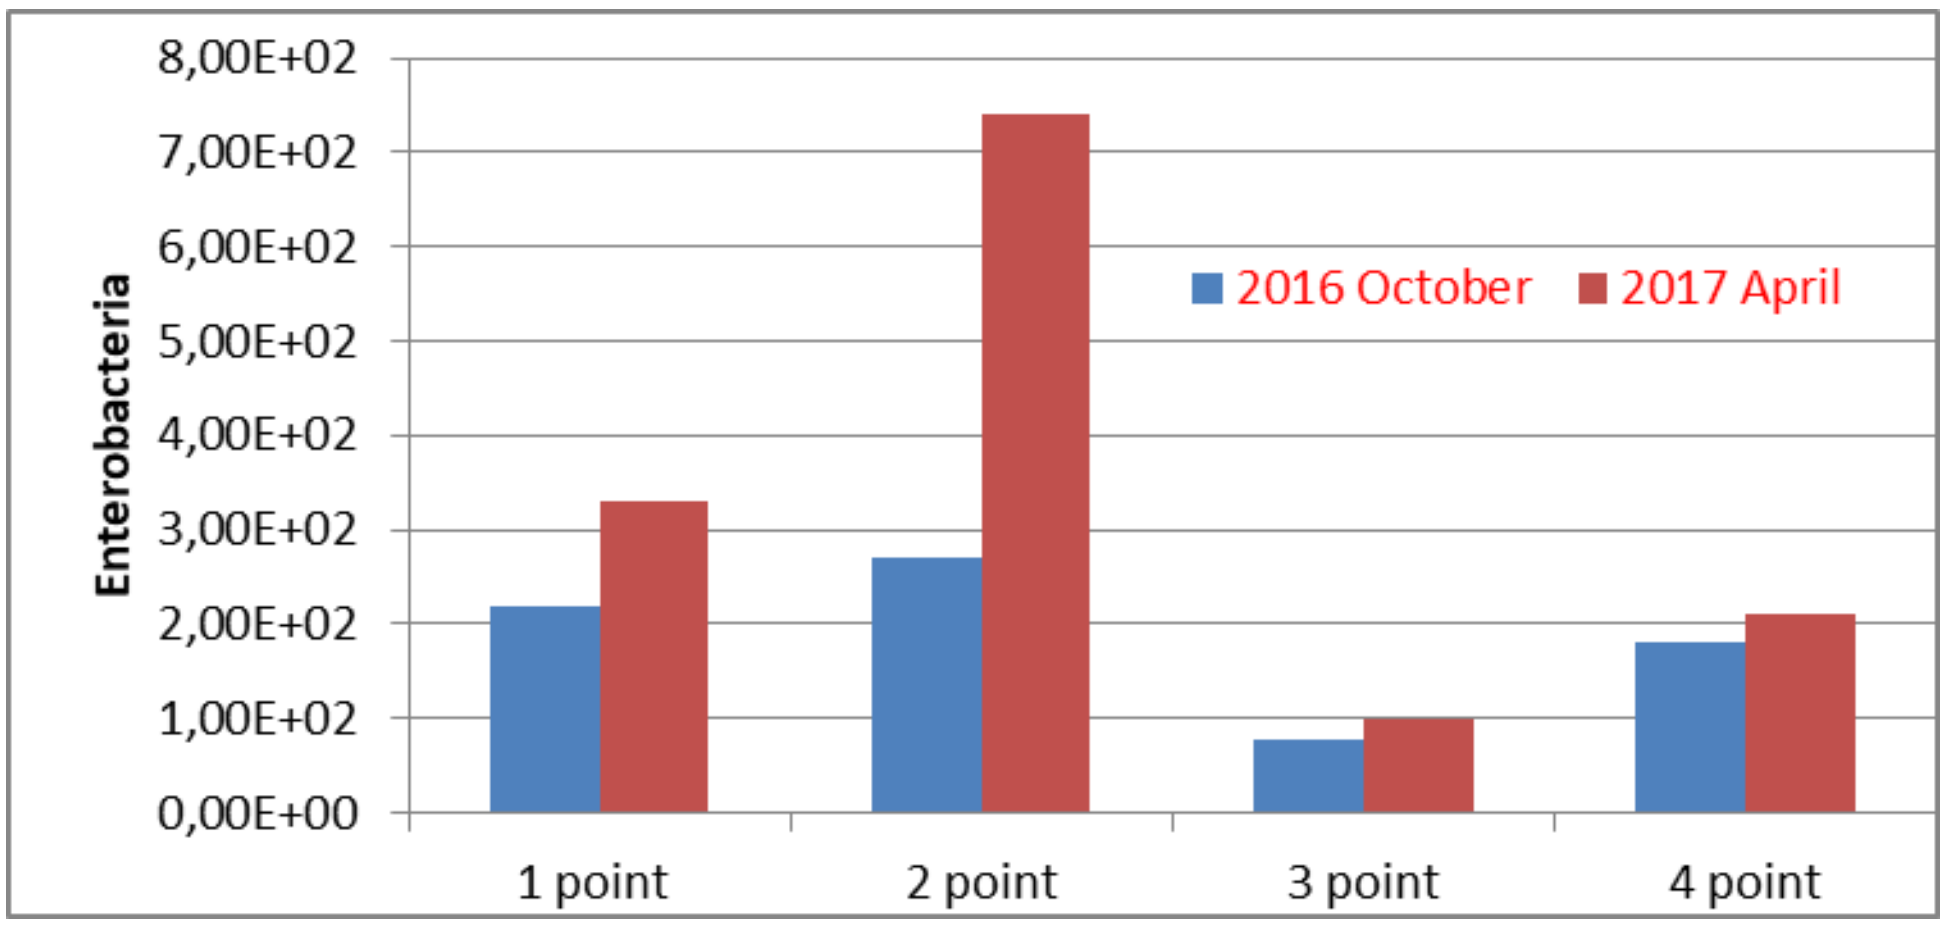
Figure 3.2.1.5. Enterobacteria assessment results 1-4 point 25 cm depths Soil result

The assessment results show that the enterobacteria concentration was higher in 2017. The highest concentration is in point 2. Coliformic bacteria assessment results are provided in Figure 3. 2.1.6.

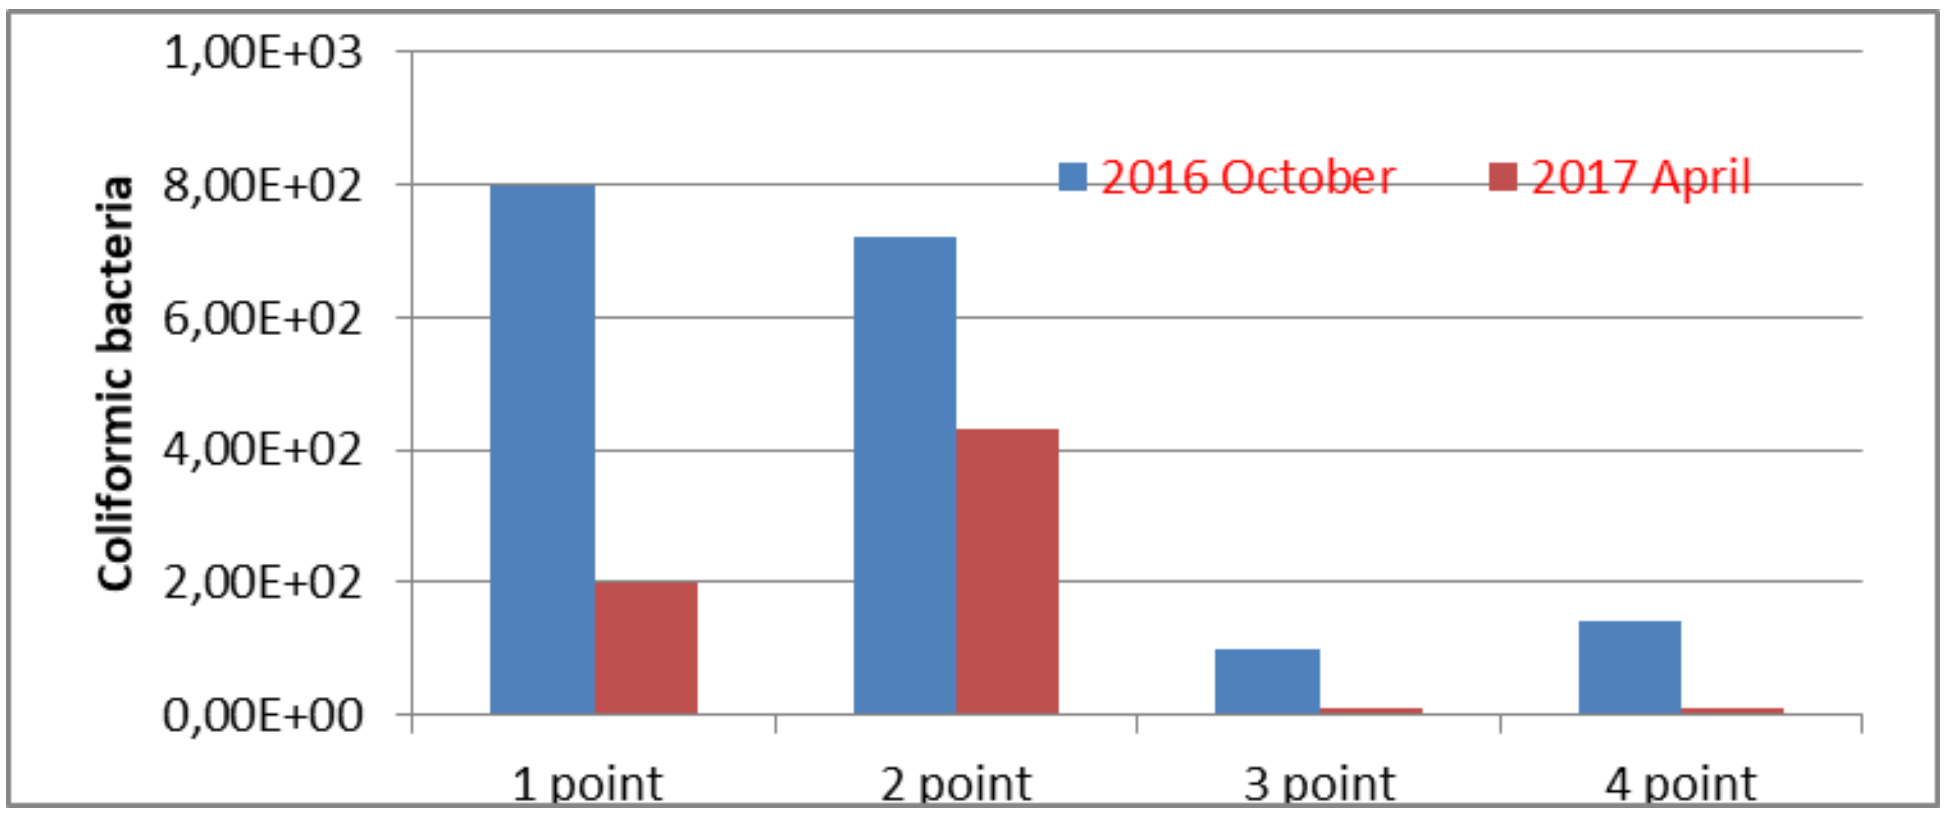
Figure 3.2.1. 6. Coliformic bacteria assessment results 1-4 point 25 cm depths Soil result

The assessment results show that the Coliformic bacteria concentration was higher in 2016. The highest concentration is in points 1 and 2. Escerichia coli bacterial assessment results are provided in Figure 3. 2.1.7.

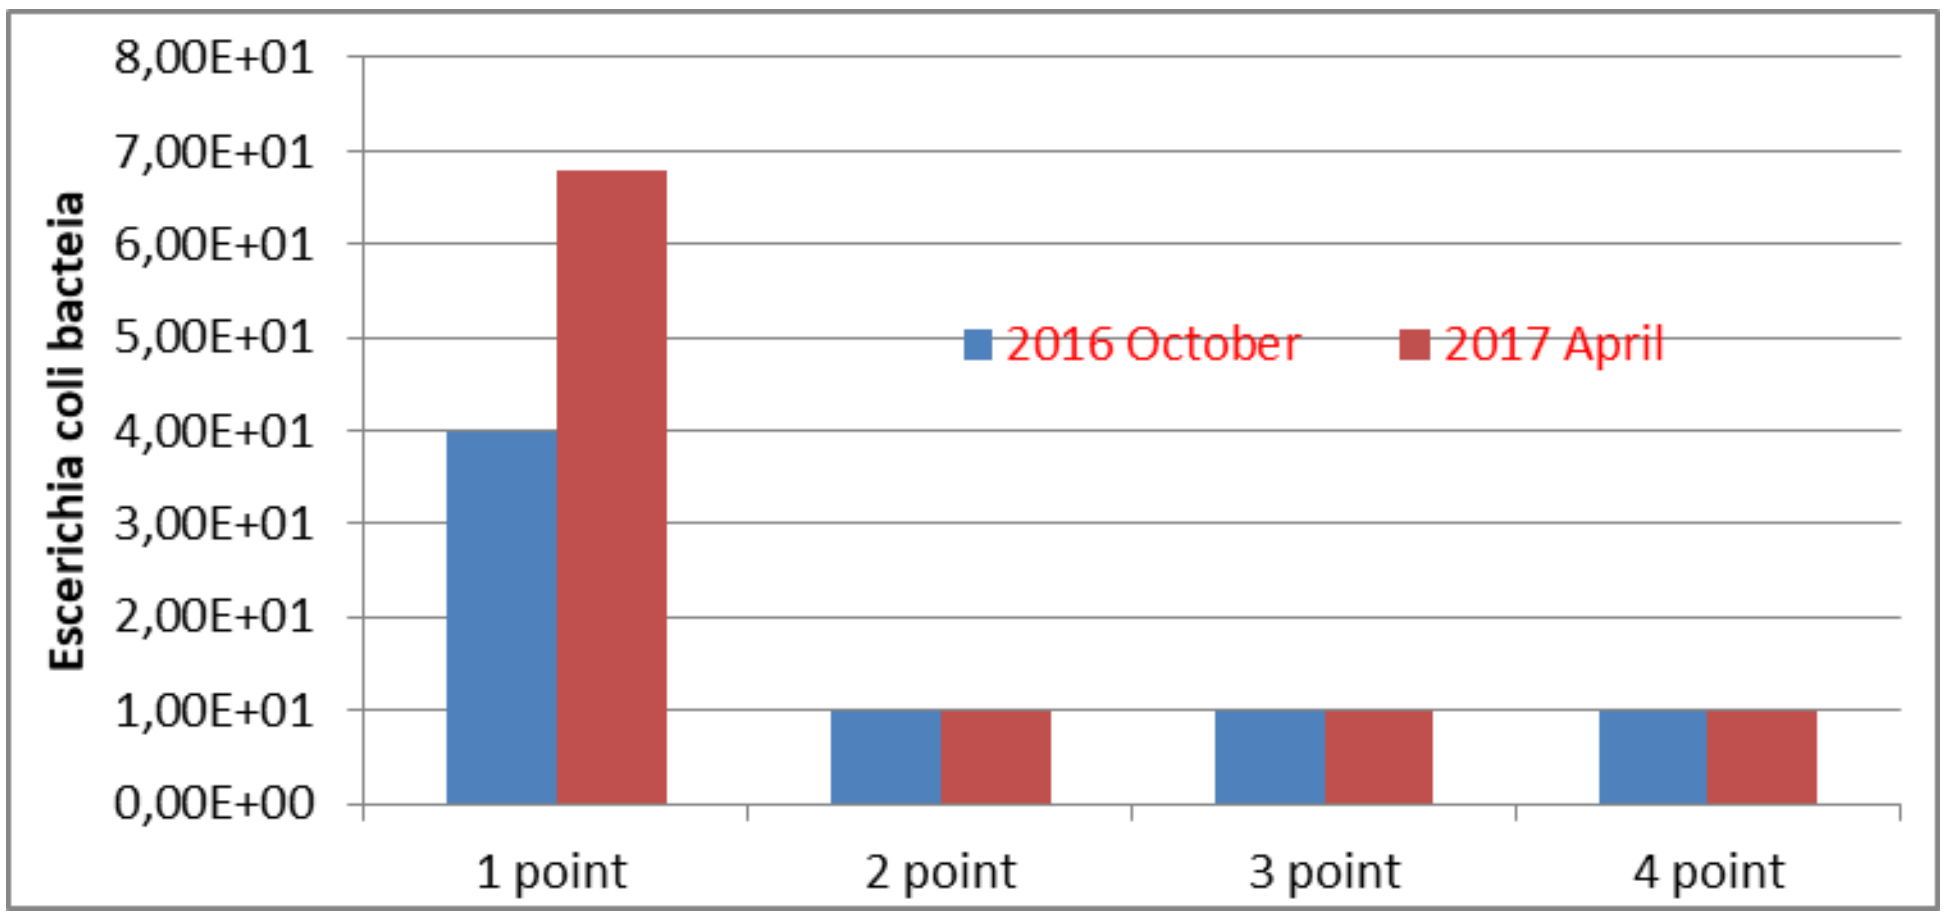
Figure 3.2.1.7. Escerichia coli bacterial assessment results 1-4 point 25 cm depths Soil result

The assessment results show that the Escerichia coli bacterial concentration was higher in 2017 in point 1. In other points the concentration is equal. Fecal colifomic bacteria assessment results are provided in Figure 3. 2.1. 8.

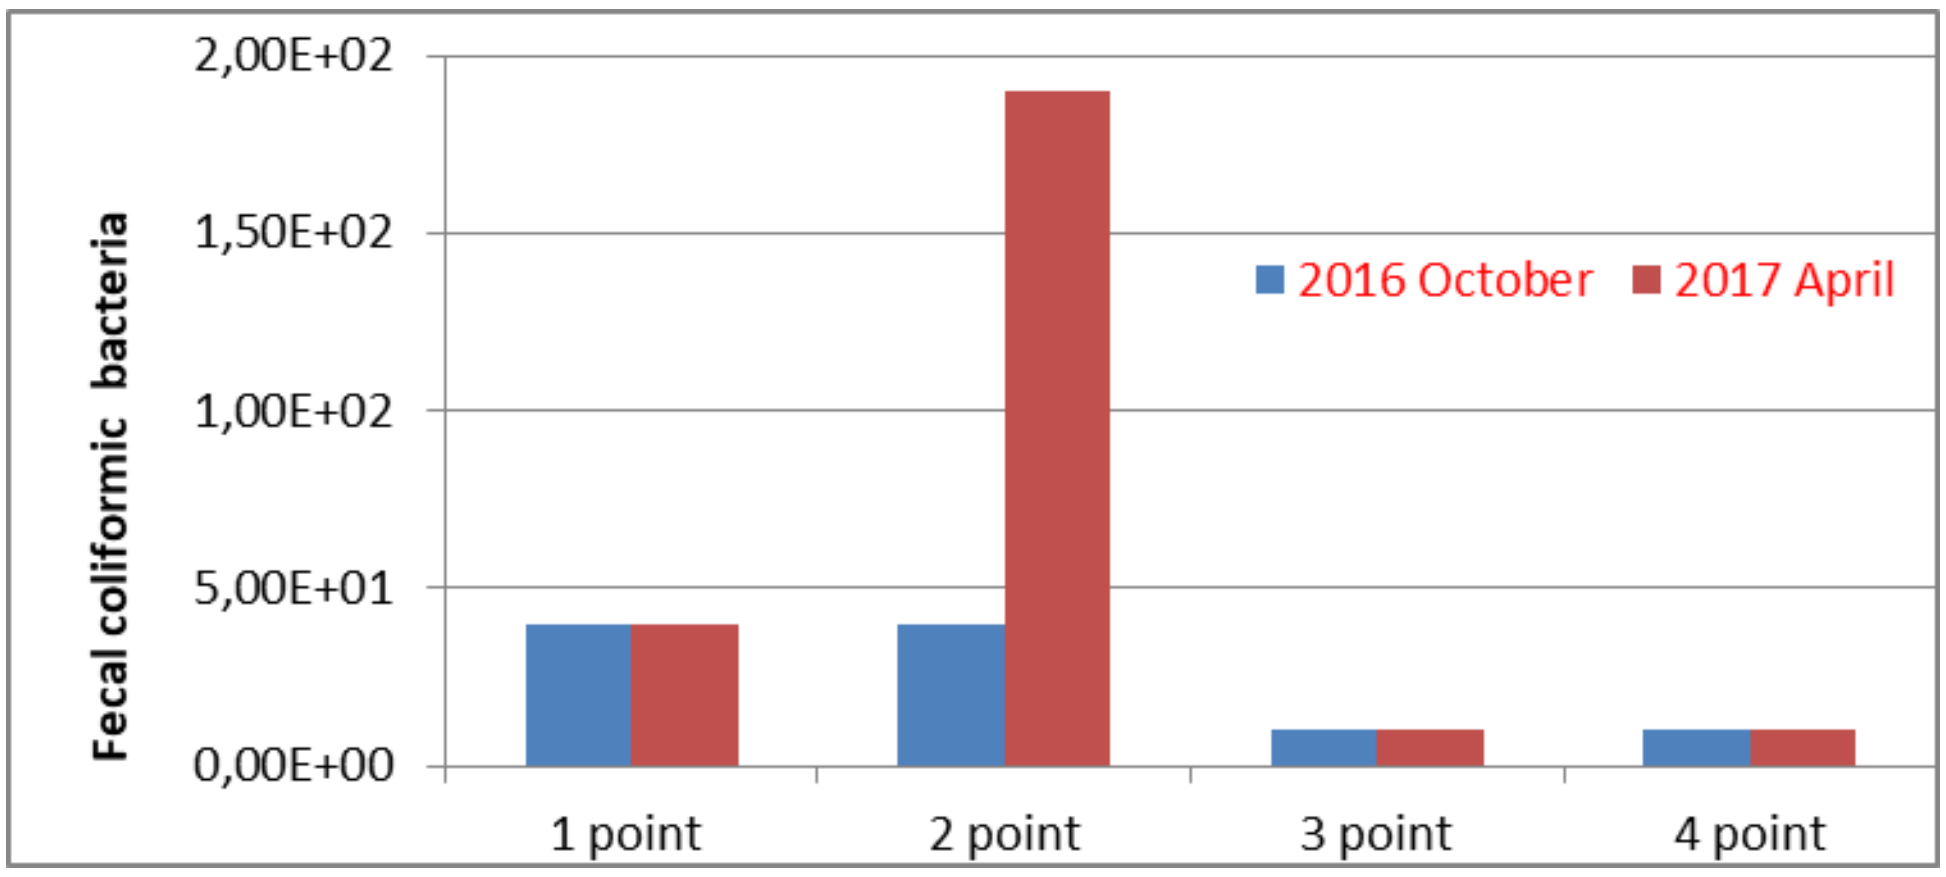
Figure 3.2.1.8. Fecal colifomic bacteria assessment results 1-4 point 25 cm depths Soil result

The assessment results show that the Fecal colifomic bacteria concentration was higher in 2017 in point 2. In other points the concentration is equal. Fecal streptococci assessment results are provided in Figure 3.2.1.9.

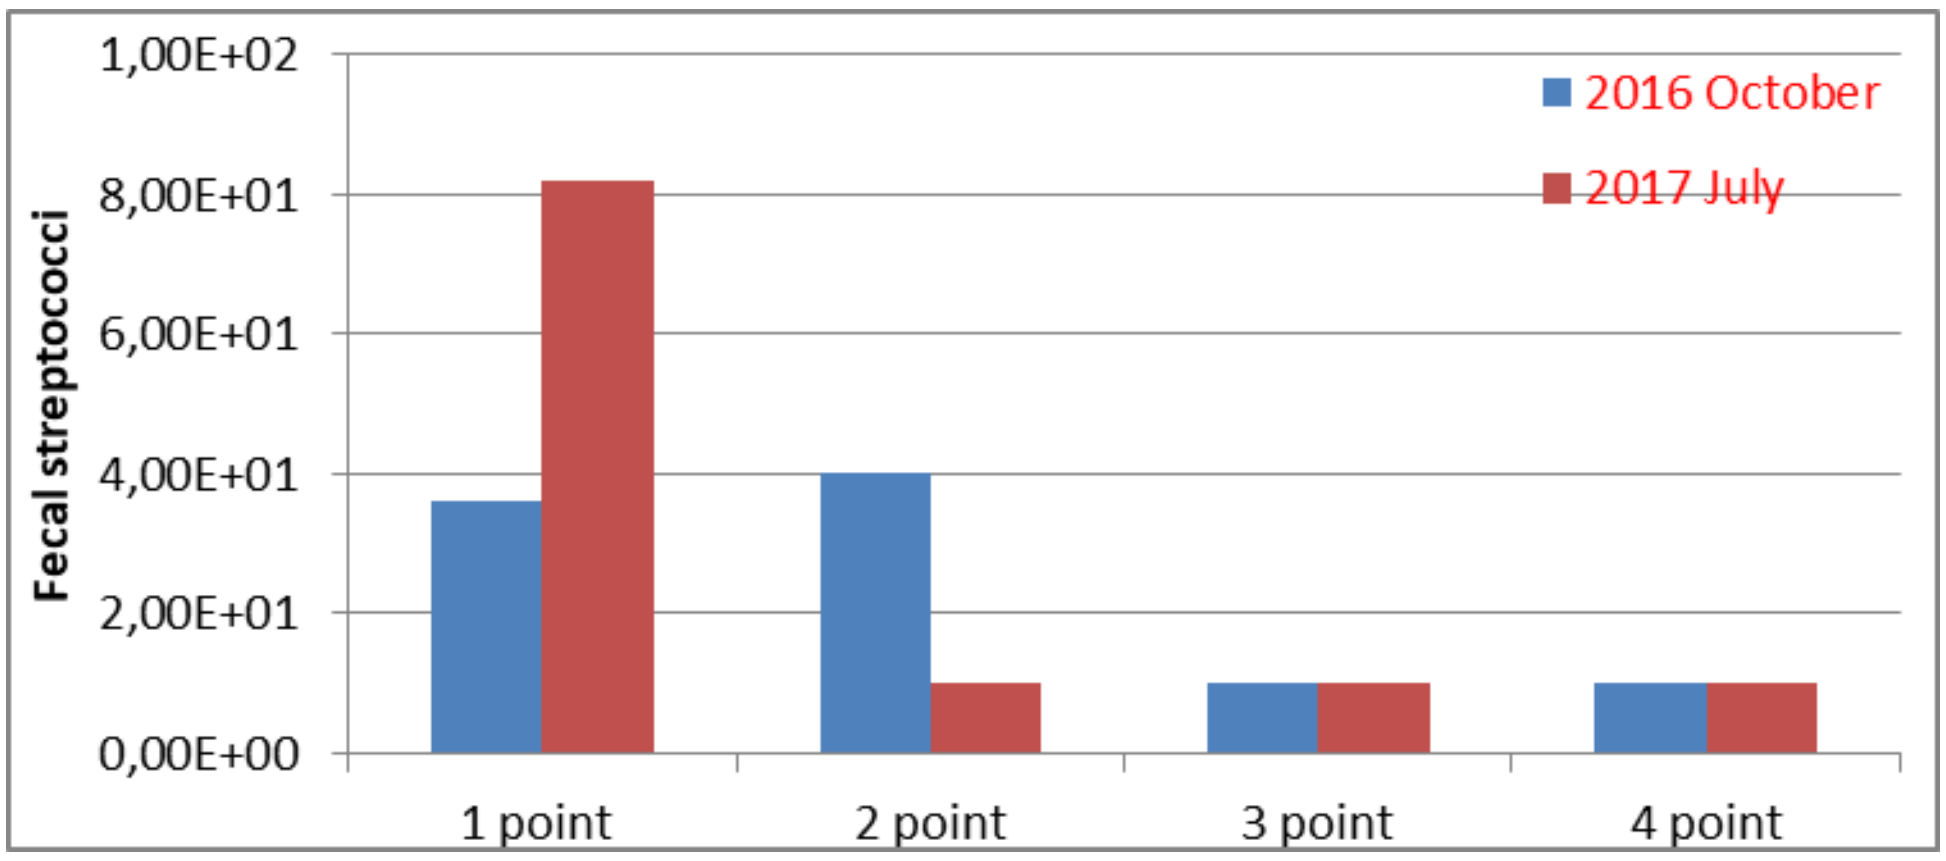
Figure 3.2.1.9. Fecal streptococci assessment results 1-4 point 25 cm depths Soil result

The assessment results show that the Fecal streptococci concentration was higher in 2017 in point 1, in 2016 - in point 2. In other points the concentration is equal.The soil quality was assessed in 4 points (on all sides of the filtration field), 100 cm deep. The soil quality in Finland is regulated by - Government Decree on the Assessment of Soil Contamination and Remediation Needs 214/2007. However, only the values of hazardous material are regulated. Table 3.2.1.8. shows soil results. Every side of the absorption field 1-4 point 25 cm depths.

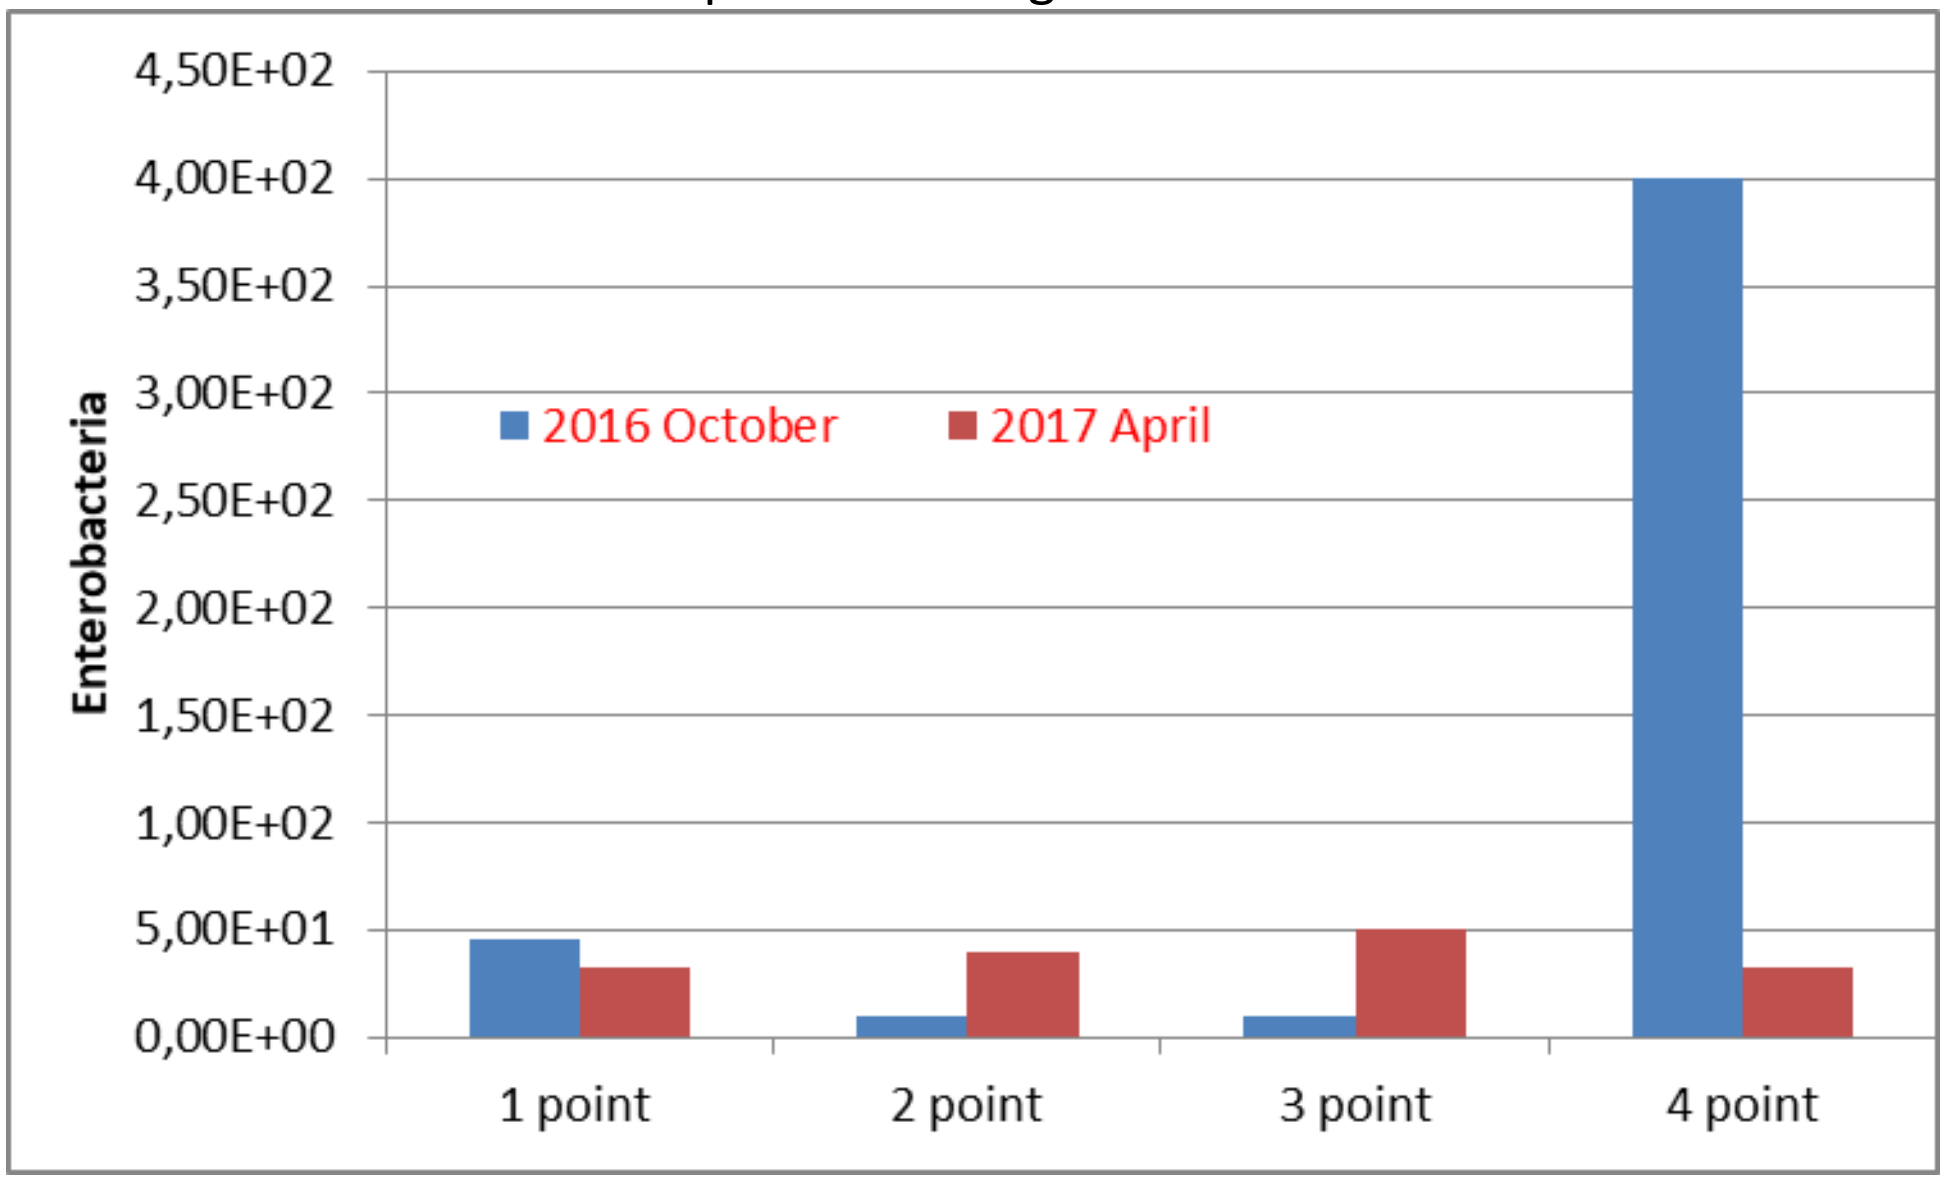
Figure 3.2.1.10. Enterobacteria assessment results 1-4 point 100 cm depths Soil results

The assessment results show that the enterobacteria concentration was the highest in 2016 in point 4. Coliformic bacteria assessment results are provided in Figure 3.2.1.11.

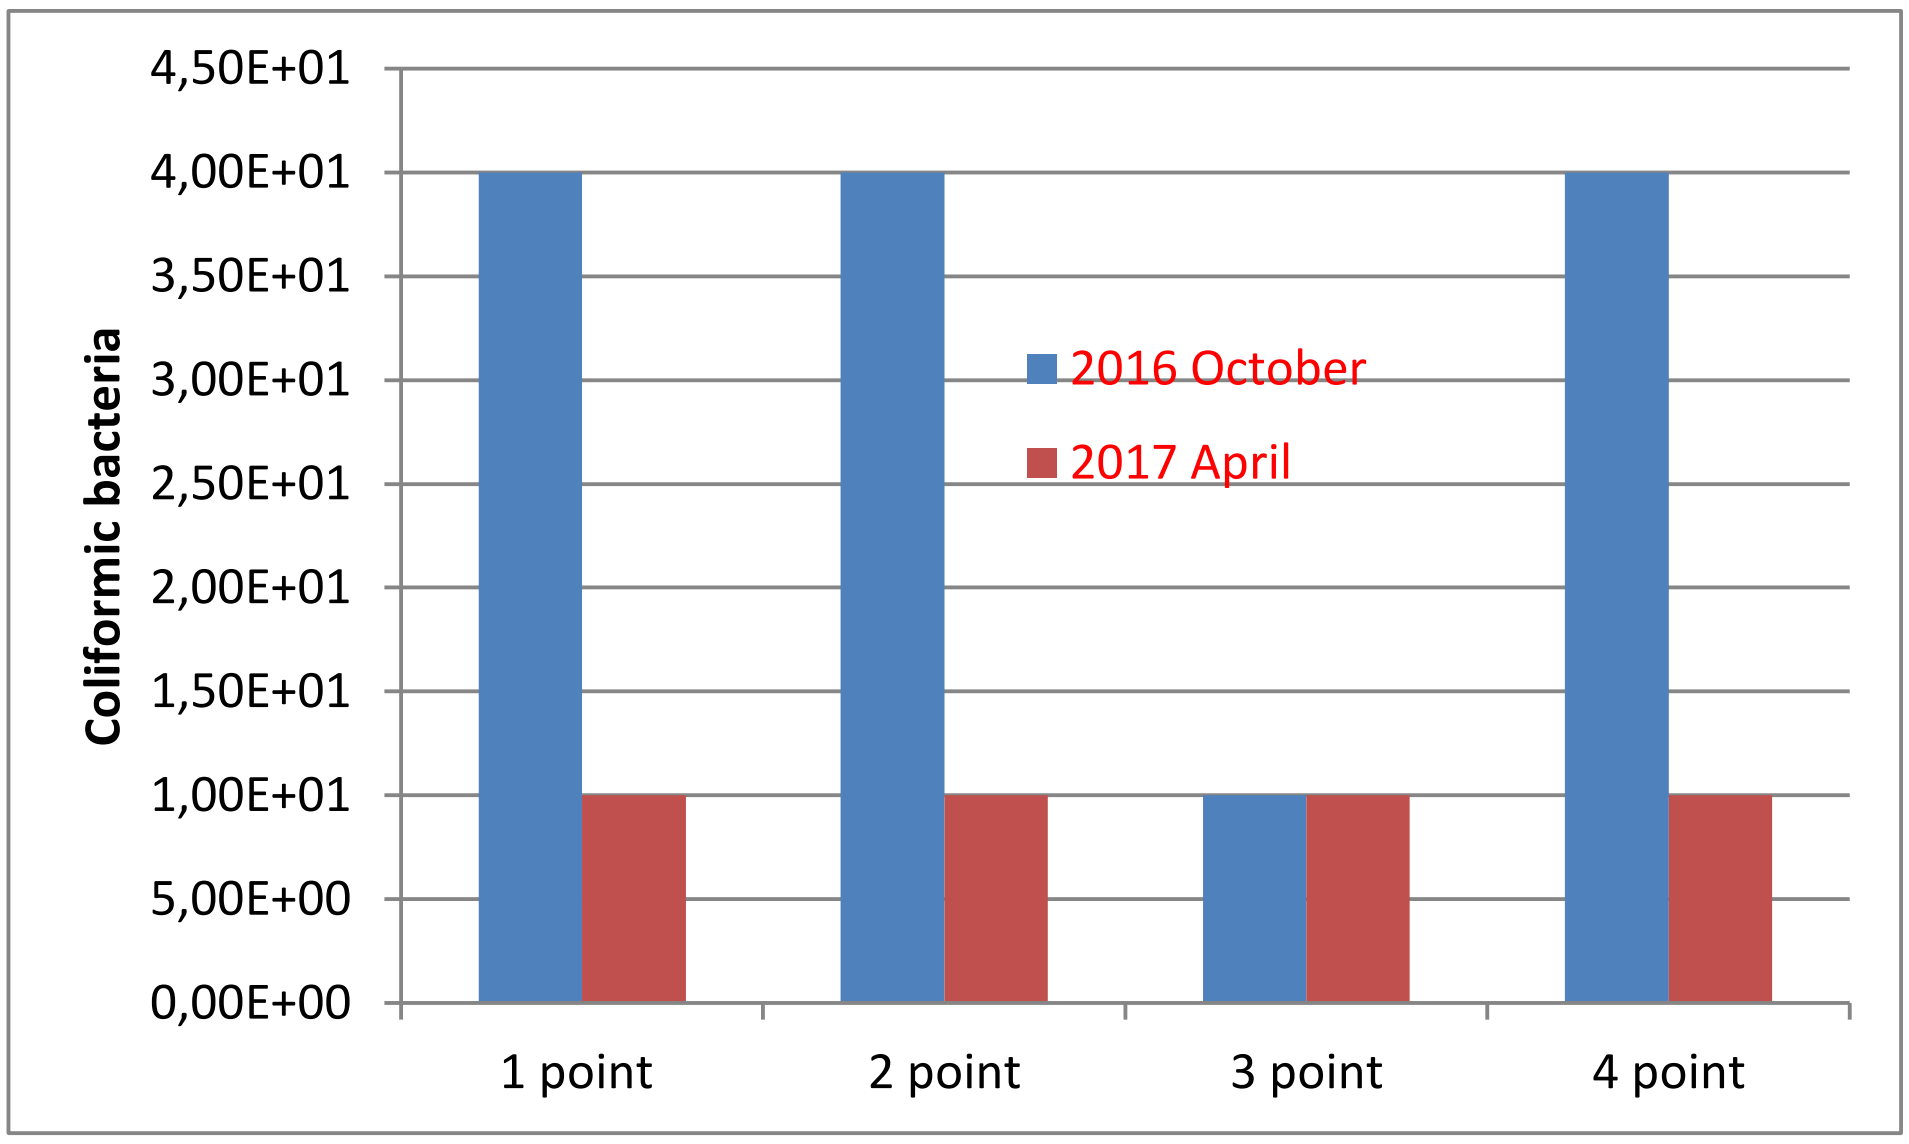
Figure 3.2.1.11. Coliformic bacteria assessment results 1-4 point 100 cm depths Soil results

The assessment results show that the Coliformic bacteria concentration was higher in 2016. The highest concentration is in points 1, 2 and 4. Escerichia coli bacterial assessment results are provided in Figure 3.2.1.12

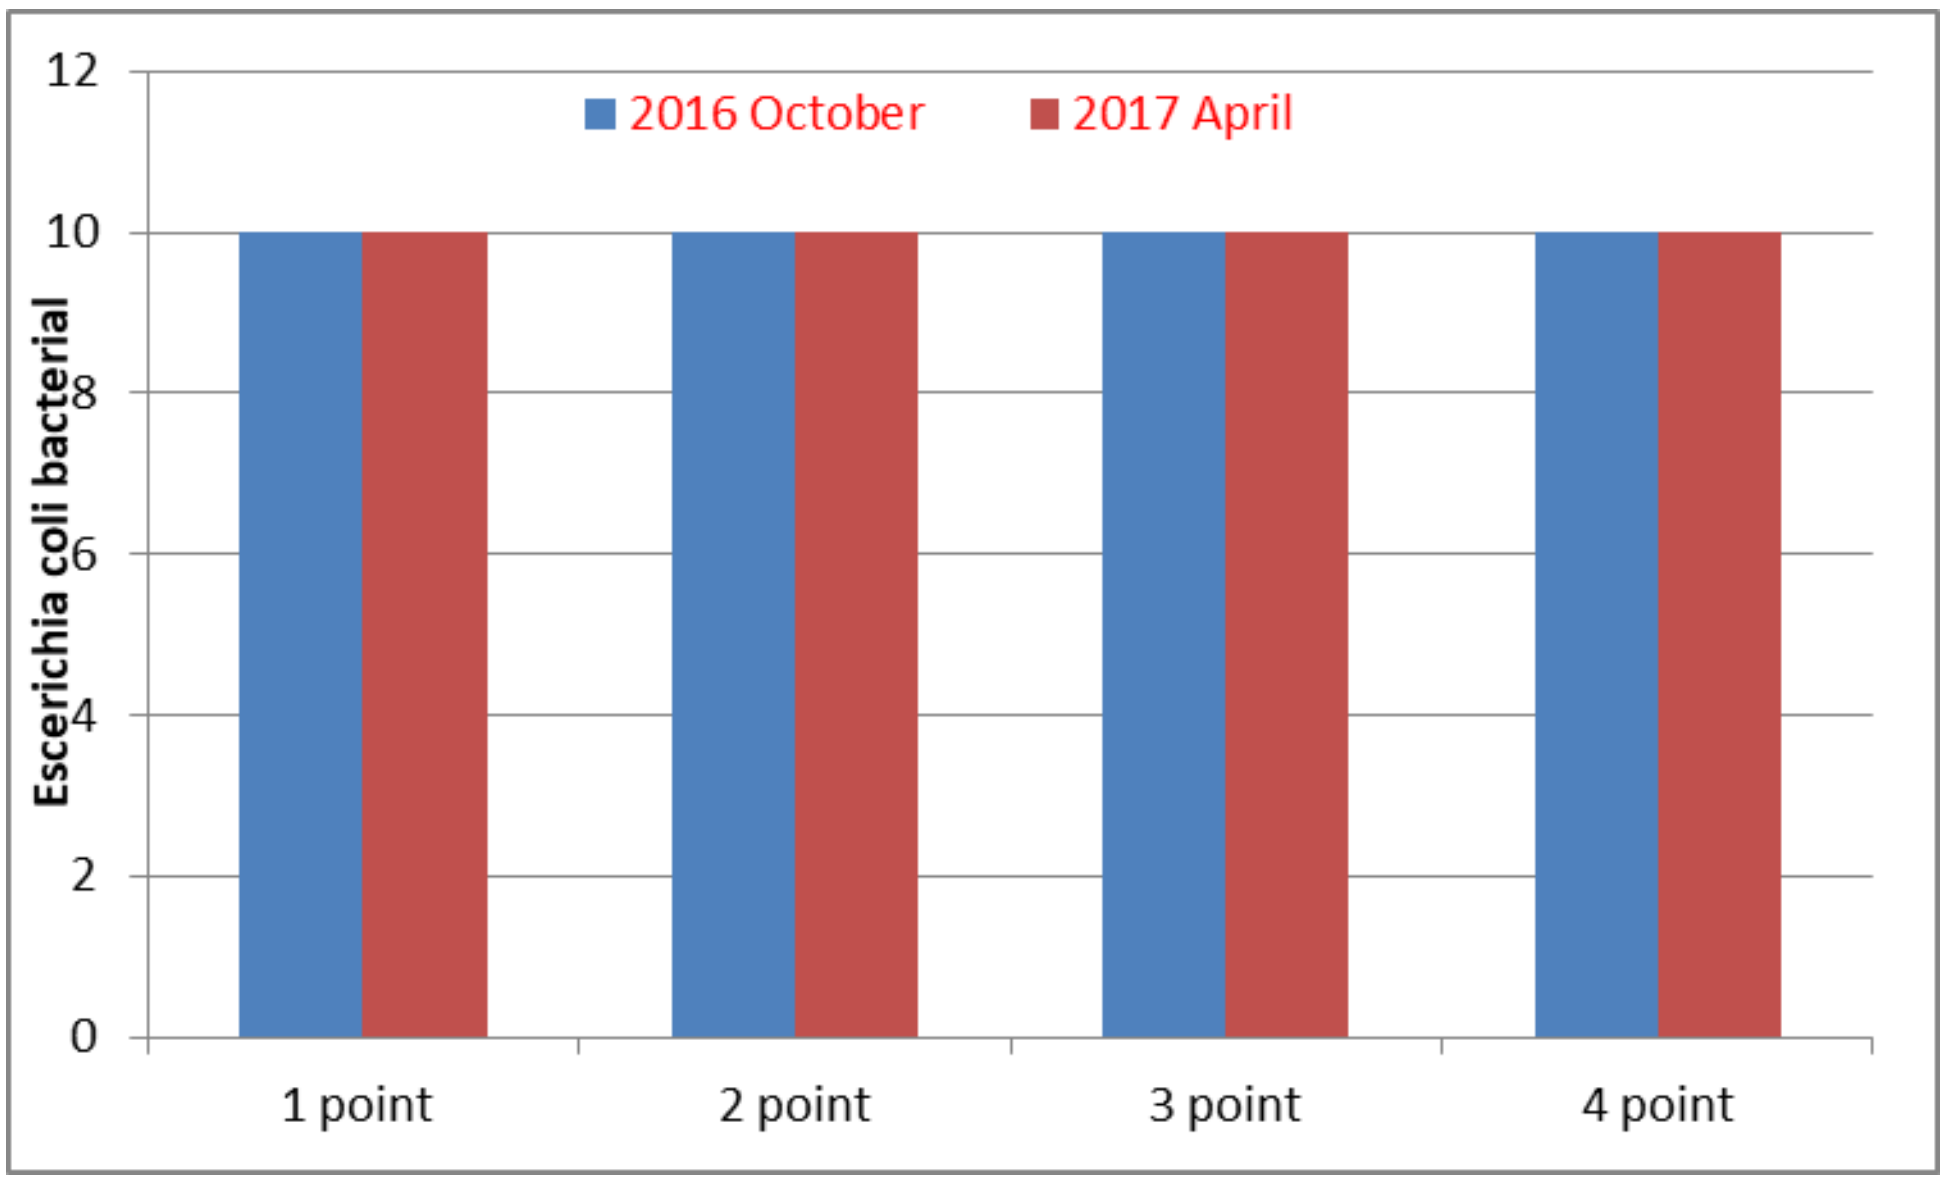
Figure 3.2.1.12. Escerichia coli bacterial assessment results -4 point 100 cm depths Soil results

The assessment results show that the Escerichia coli bacterial concentration was equal in all of the points. Fecal colifomic bacteria assessment results are provided in Figure 3.2.1.13.

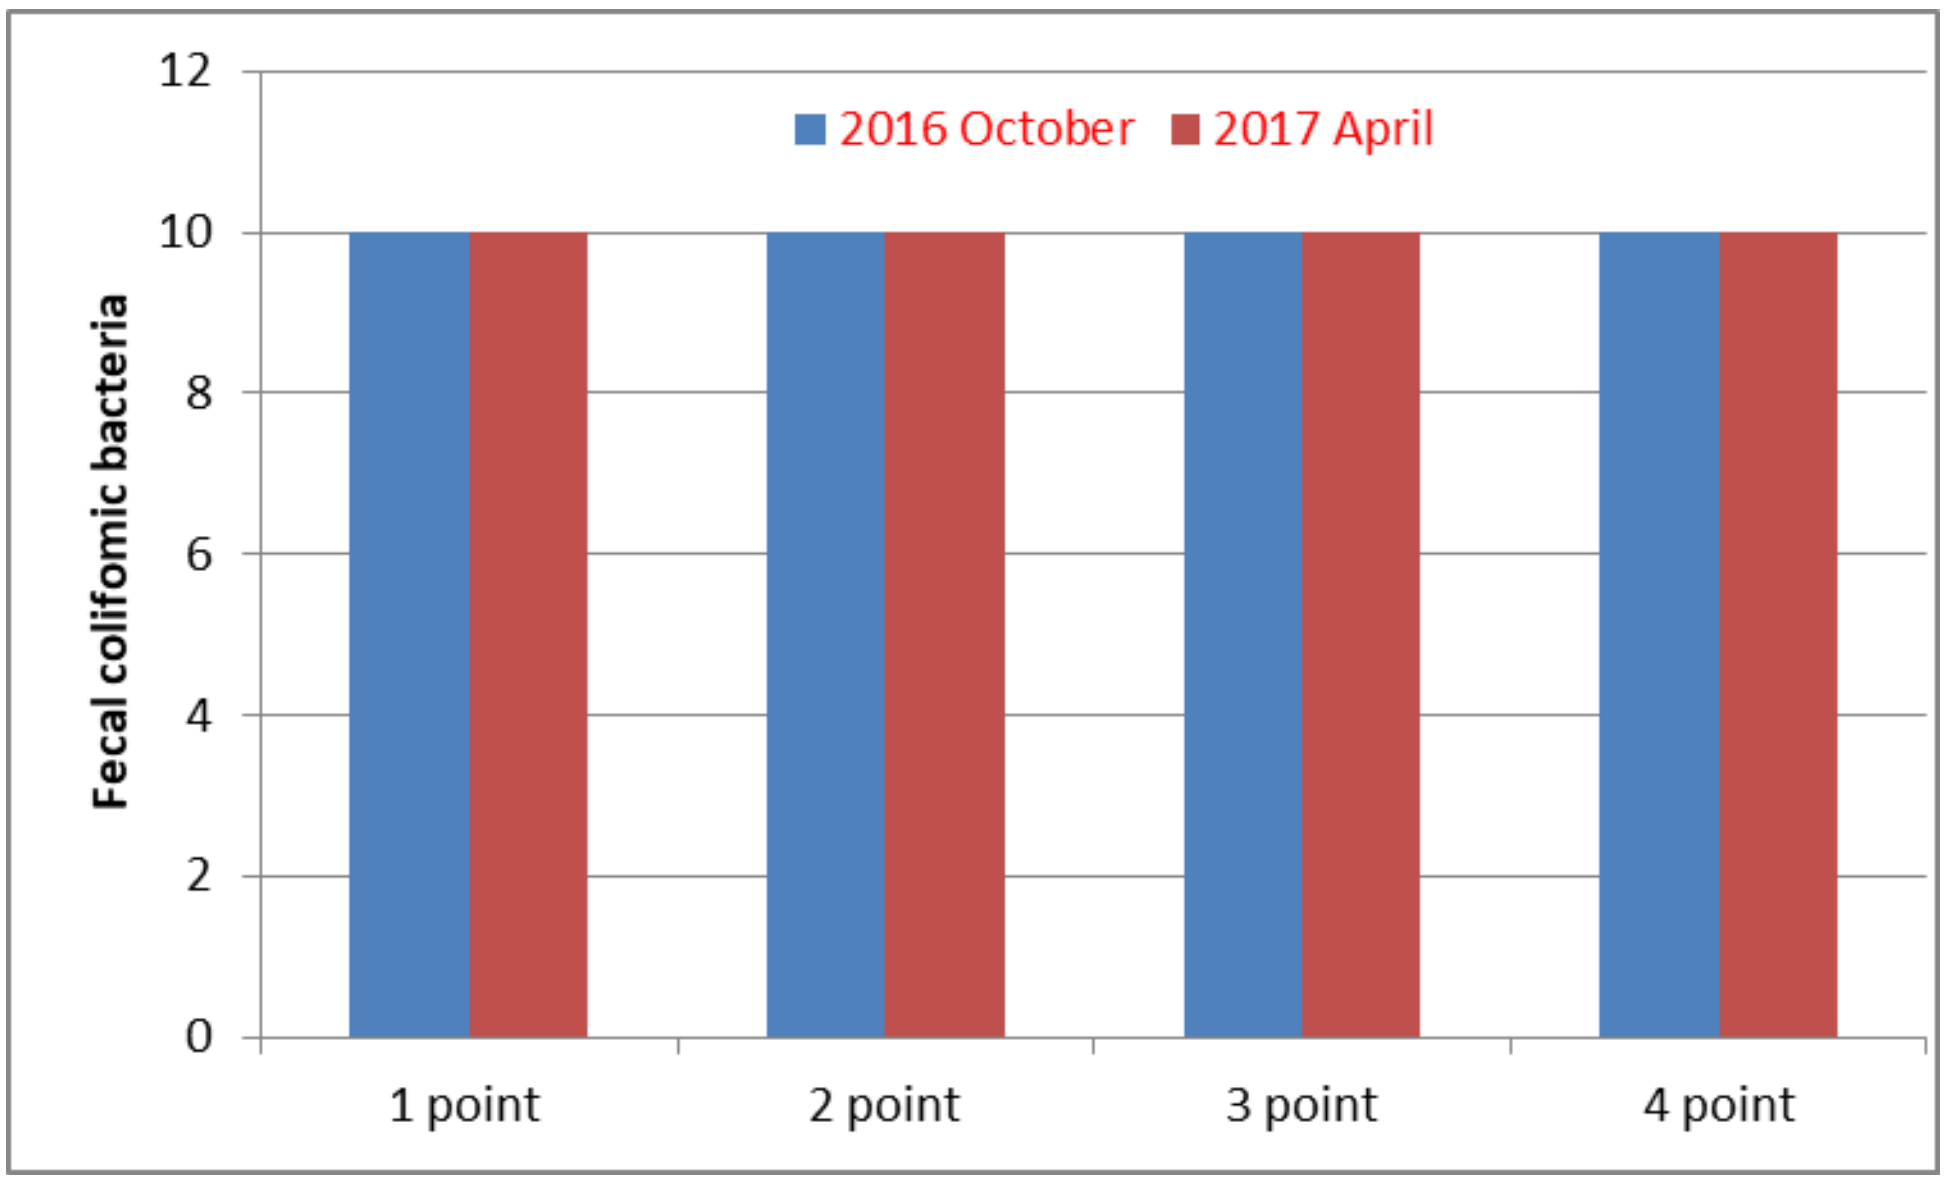
Figure 3.2.1.13. Fecal colifomic bacteria assessment results 1-4 point 100 cm depths Soil results

The assessment results show that the Fecal colifomic bacteria concentration was equal in all of the points. Fecal streptococci assessment results are provided in Figure 3.2.1.14.

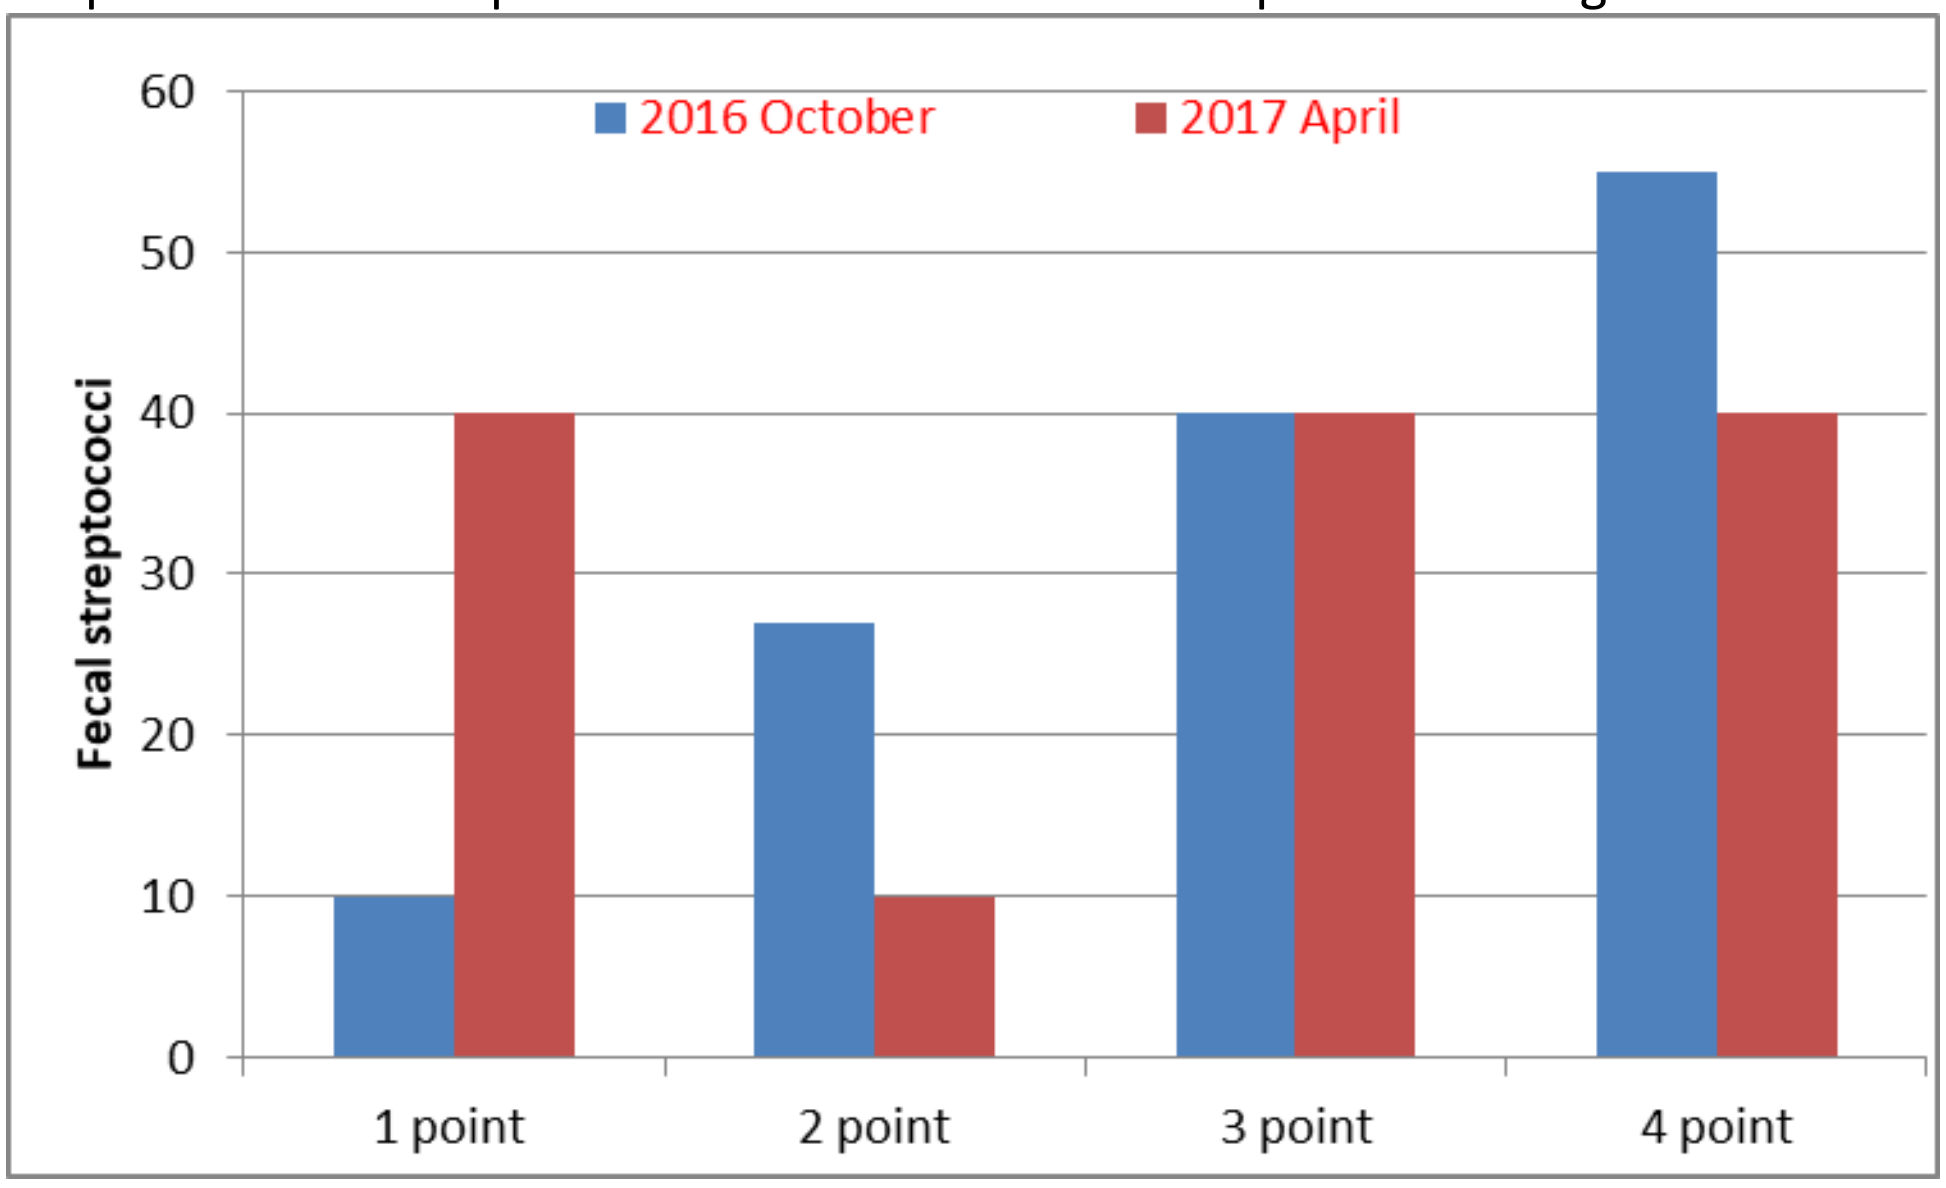
Figure 3.2.1.14. Fecal streptococci assessment results 1-4 point 100 cm depths Soil results

The assessment results show that Fecal streptococci concentration was higher in 2016 in point 4, in 2017 - in points 1, 3 and 4 the concentration was equal.

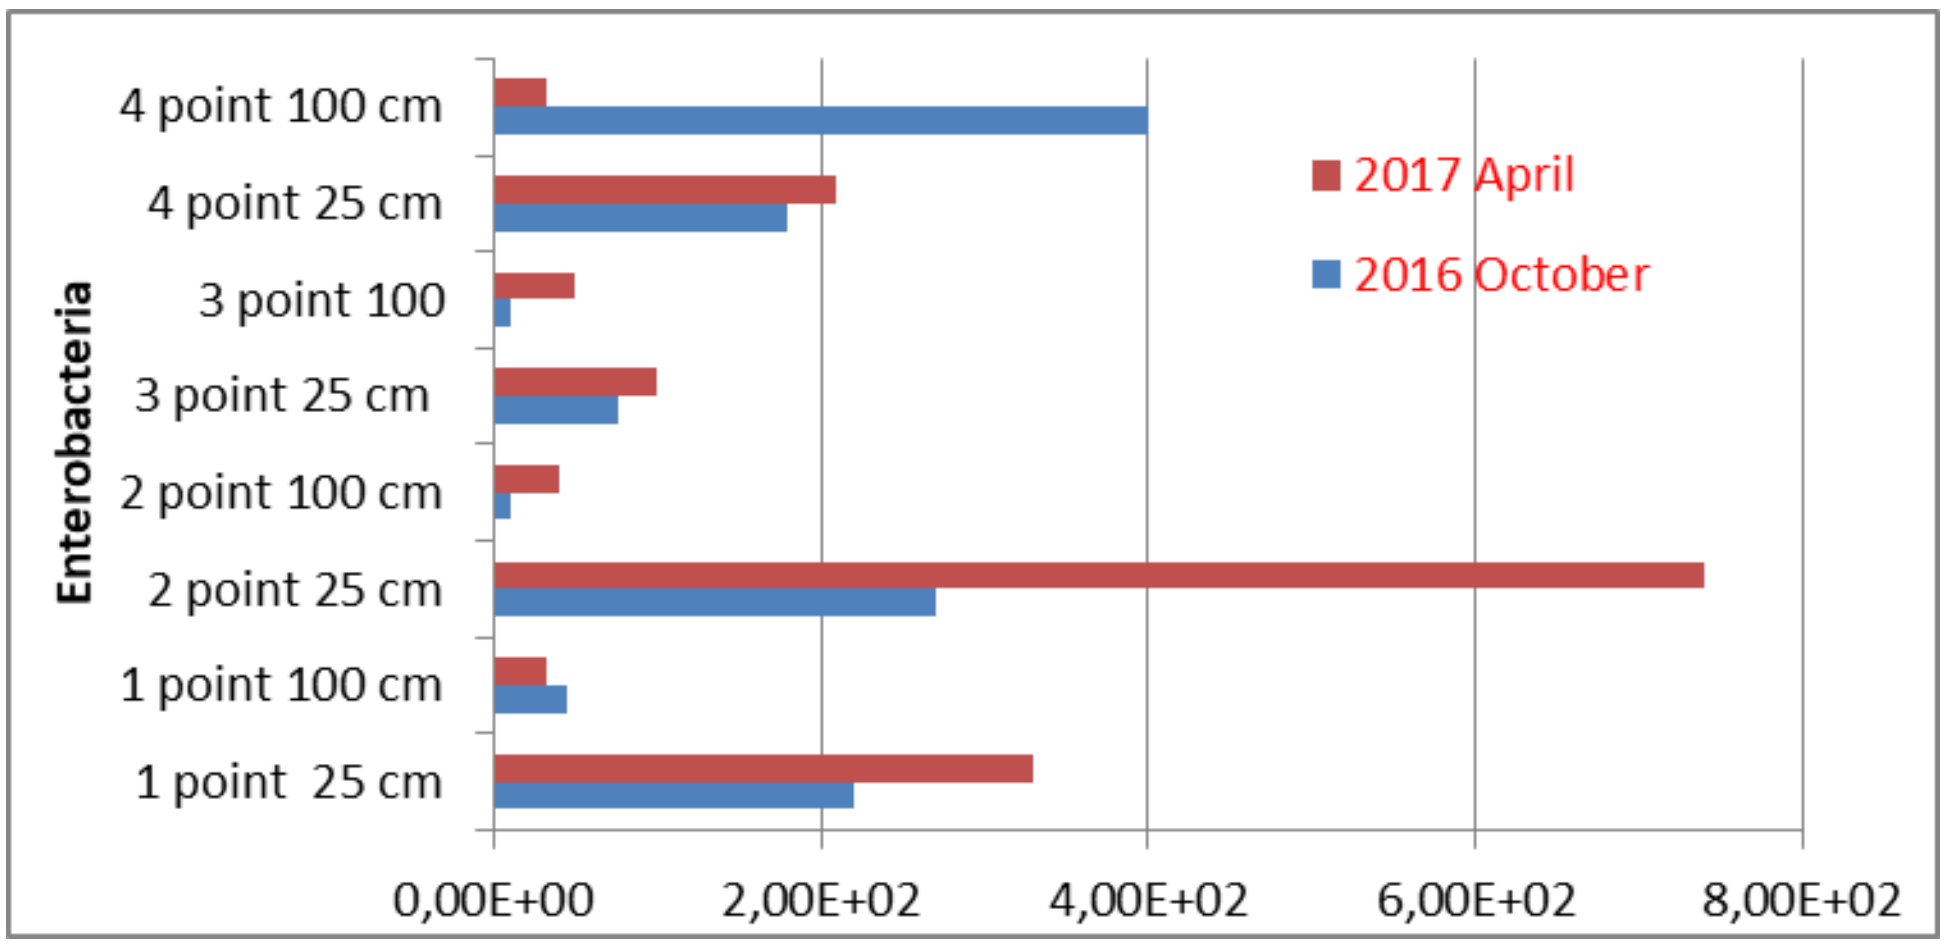
3.2.1.15 Figure. Enterobacteria assessment results 1-4 point 25 and 100 cm depths Soil results

It was found that in all of the points the Enterobacteria concentration was higher in 25-cm-deep soil than 100-cm-deep soil, except for point 4 in October of 2016.
