The chemical and microbiological assessment of water and soil samples

FINDING THE BEST FITTING SOLUTIONS FOR WASTEWATER MANAGEMENT IN VILLAGES

VillageWaters Project
Research about Wastewater Treatment Systems

Report number 1

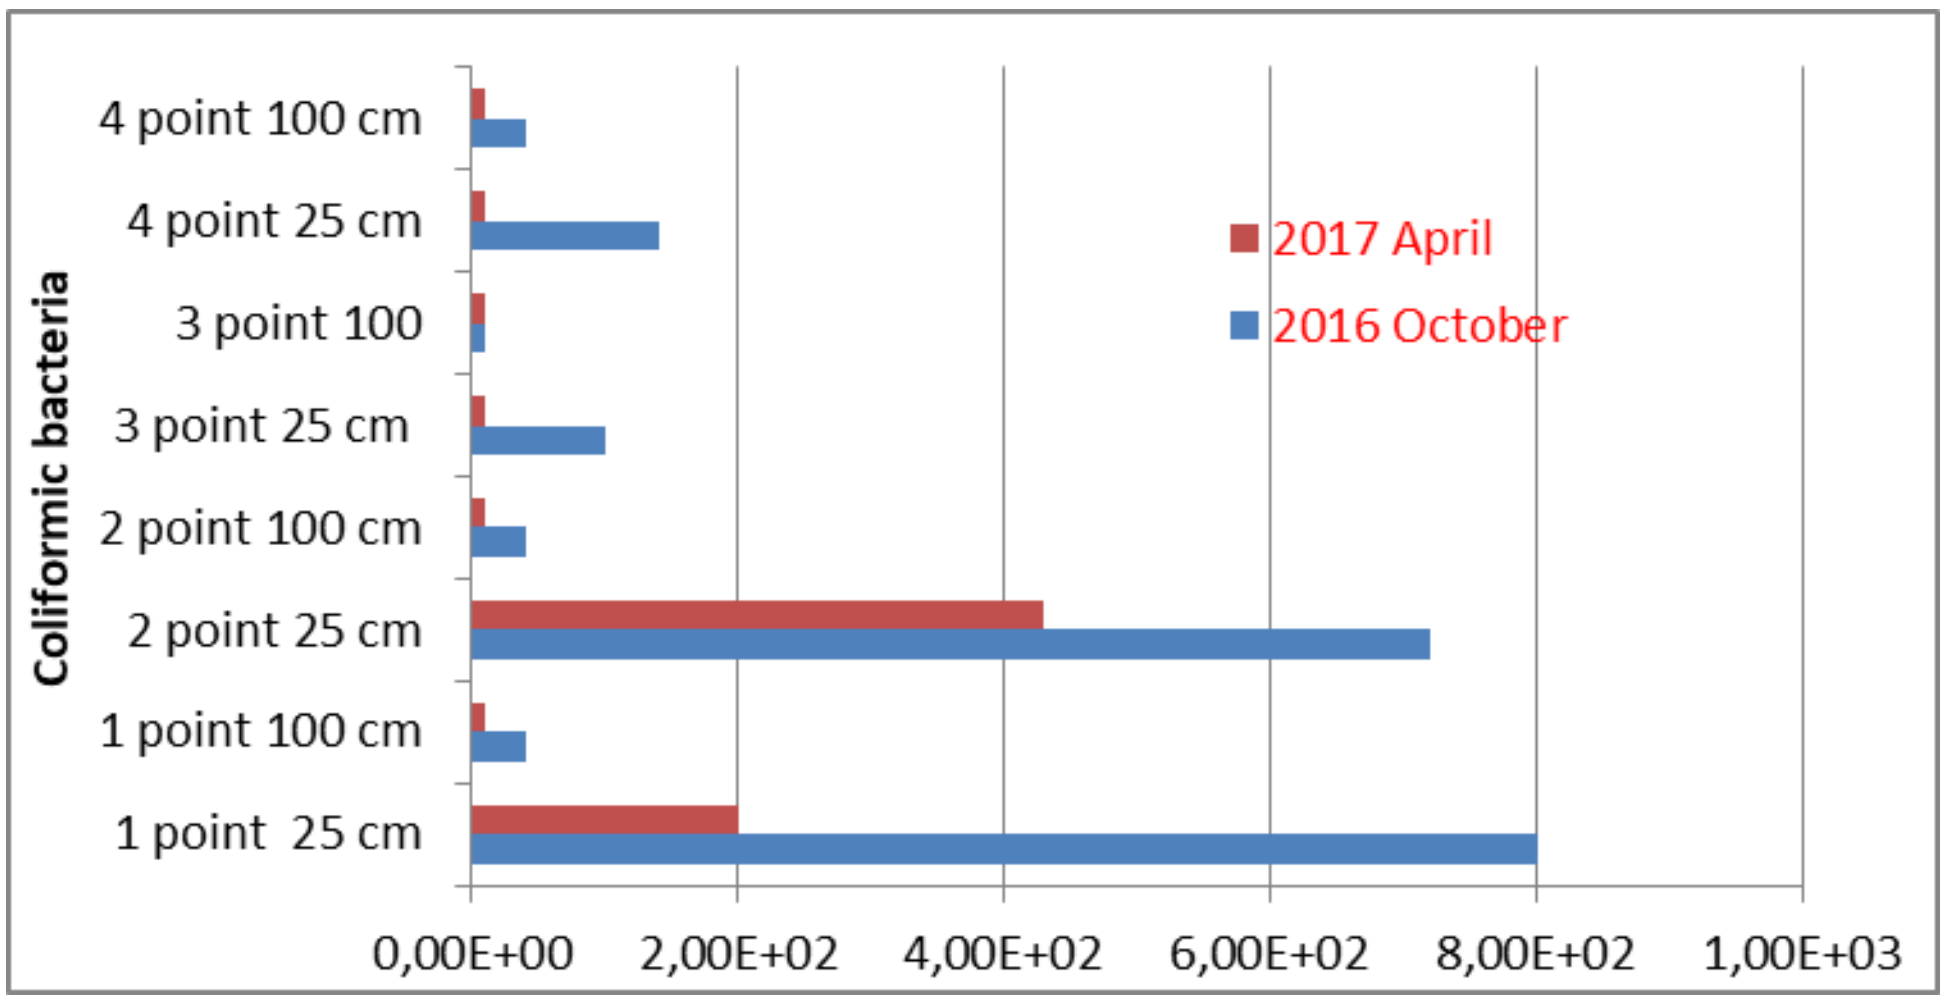
3.2.1.16 Figure. Coliformic bacteria assessment results 1-4 point 25 and 100 cm depths Soil results

It was found that in all of the points the Coliformic bacteria concentration was higher in 25-cm-deep soil than 100-cm-deep soil.

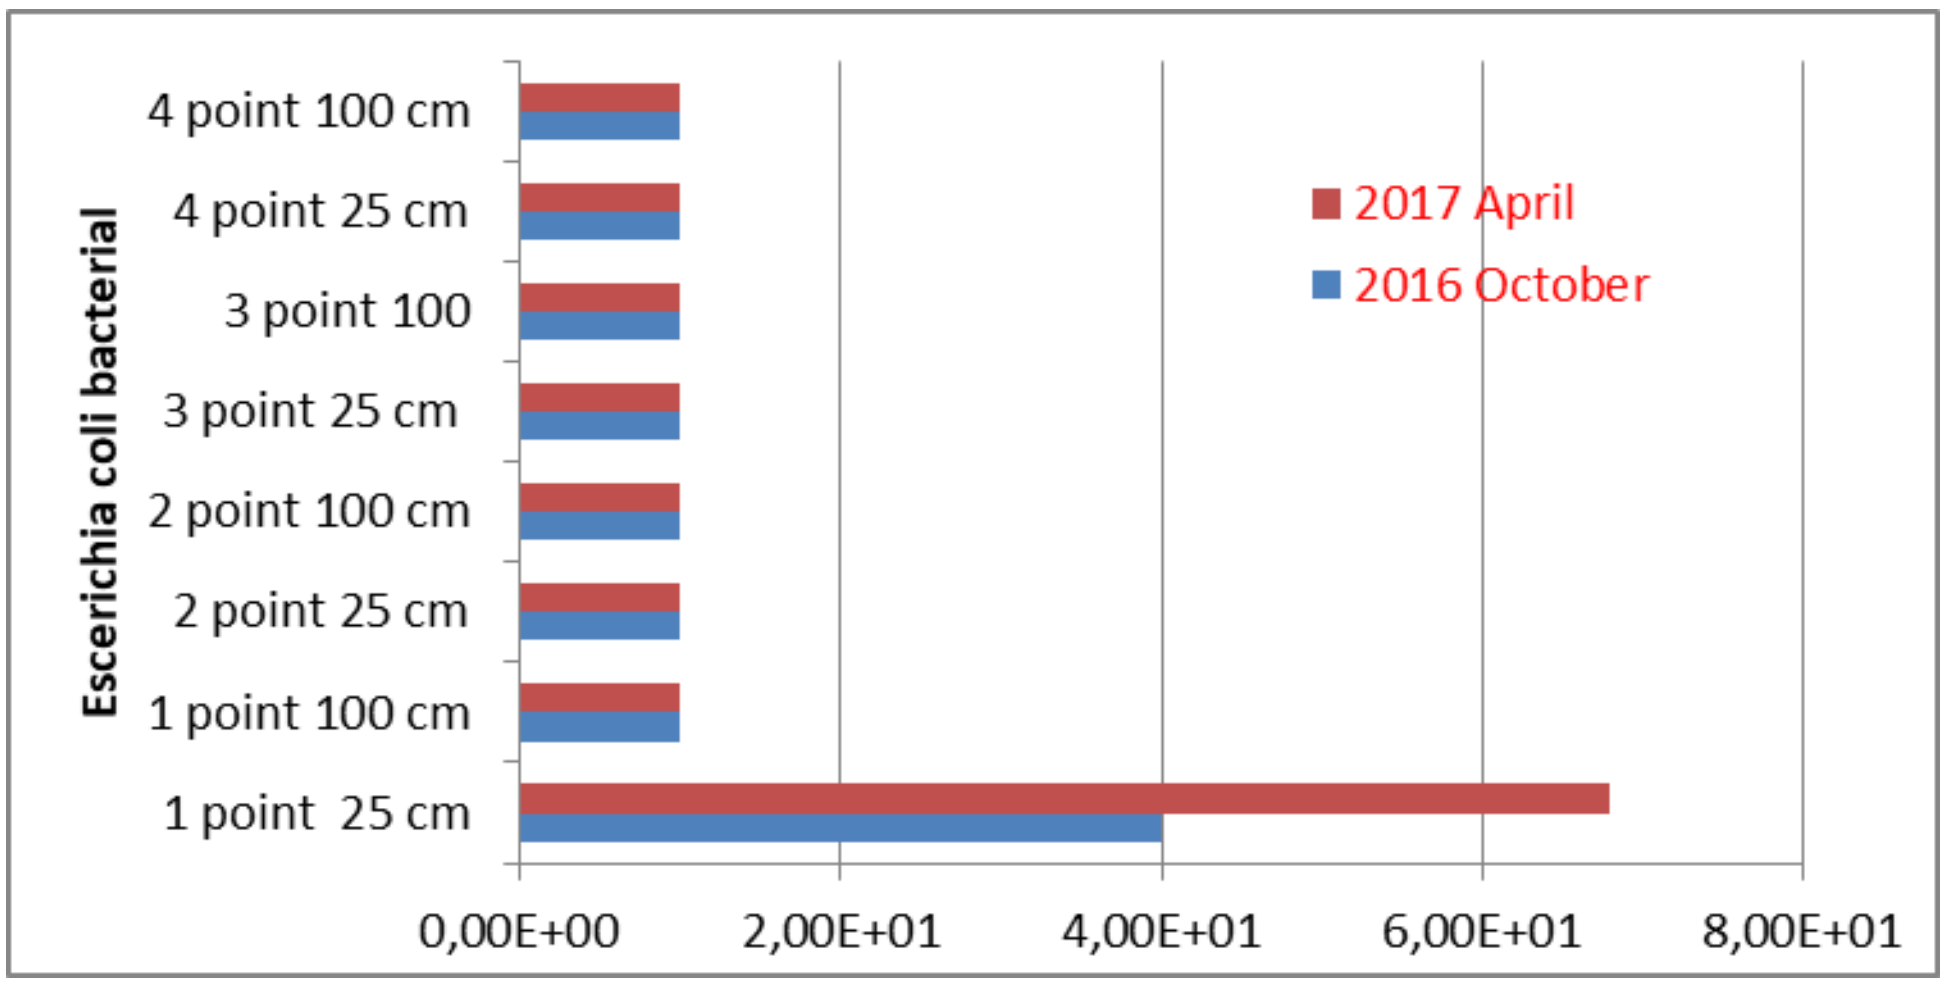
3.2.1.17 Figure. Escerichia coli bacterial assessment results 1-4 point 25 and 100 cm depths Soil results

It was found that in all of the points the Escerichia coli bacterial concentration was equal, except for point 1 – there it was higher in 25-cm-deep soil.

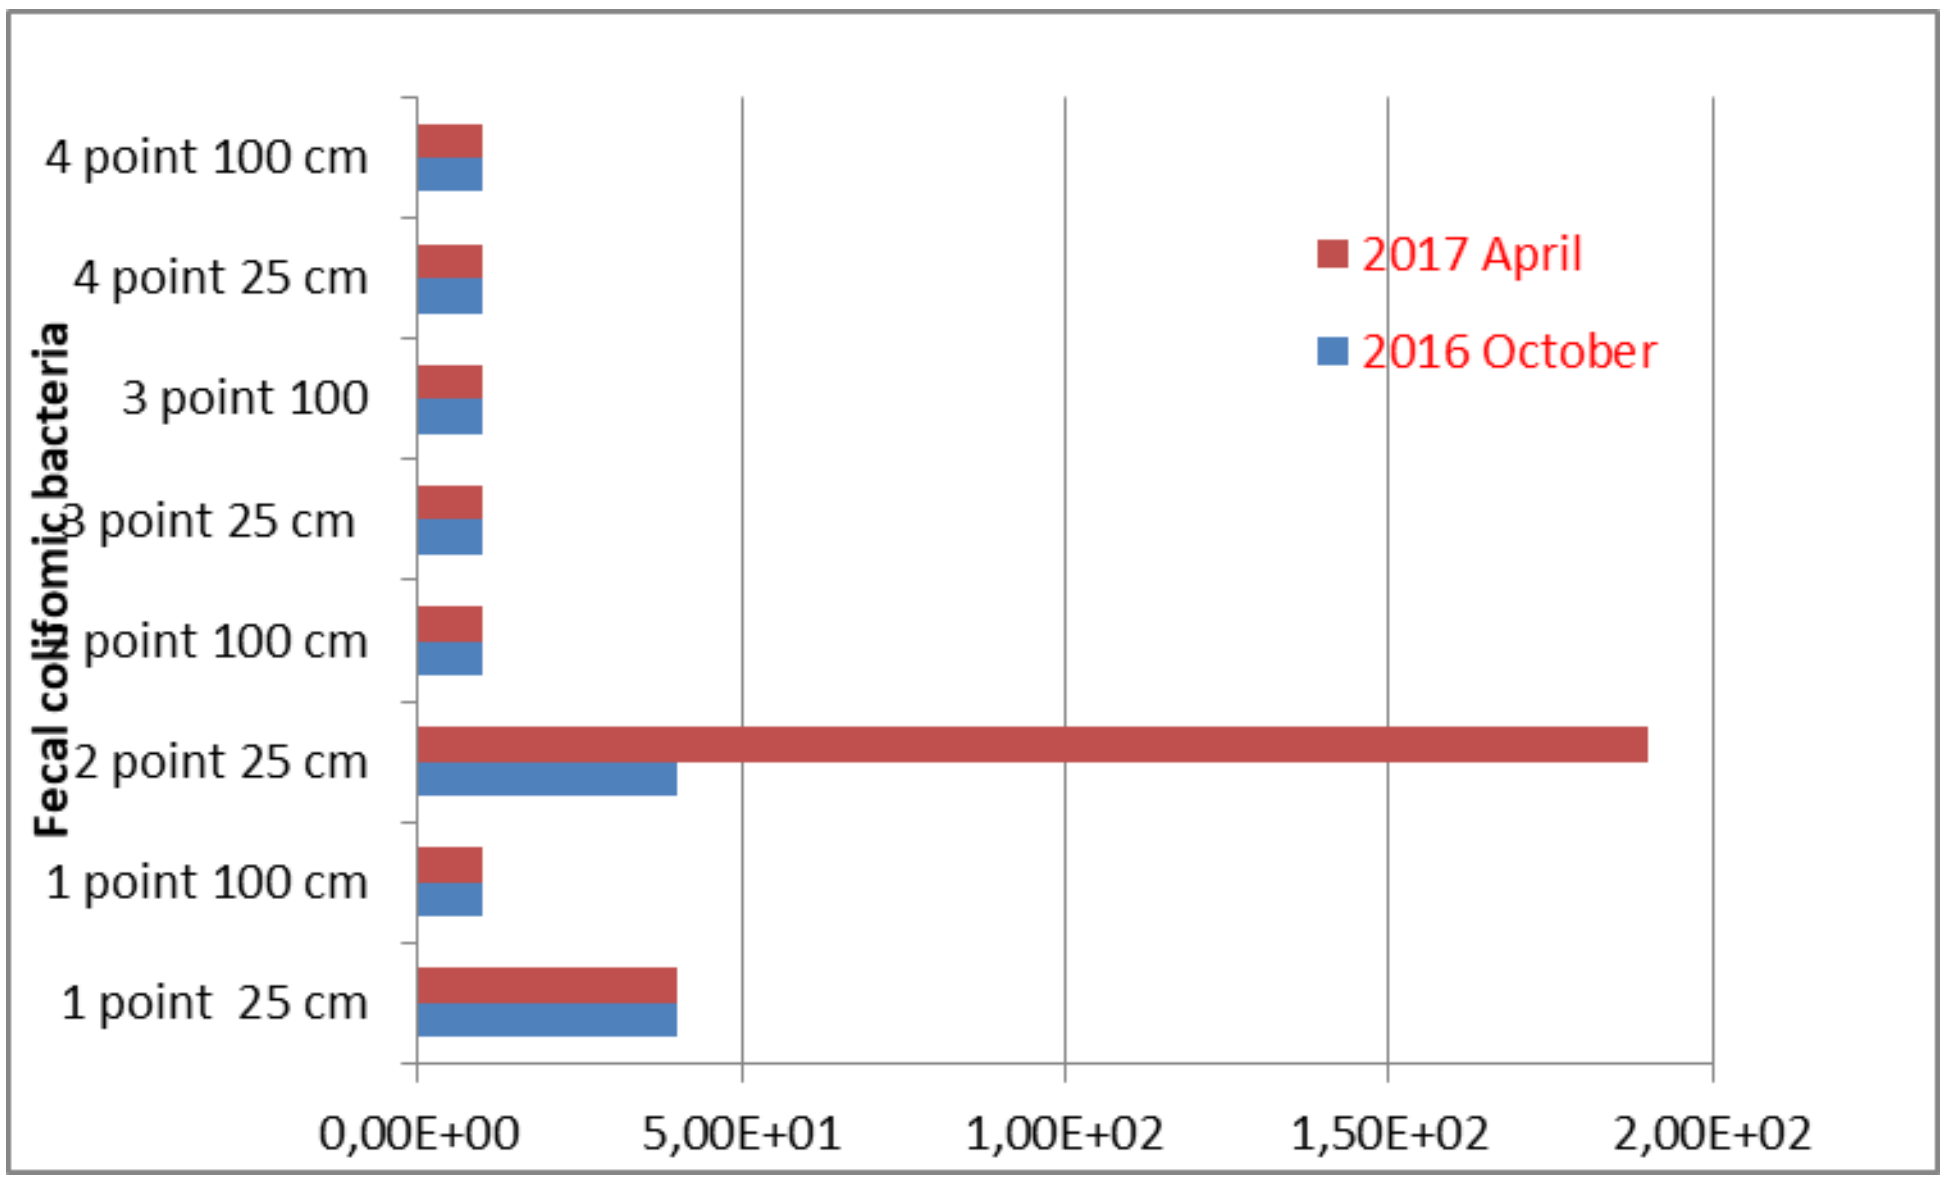
3.2.1.18. Figure. Fecal colifomic bacteria assessment results 1-4 point 25 and 100 cm depths Soil results

It was found that in all of the points the Fecal colifomic bacteria concentration was equal, except for points 1 and 2 – there it was higher in 25-cm-deep soil.

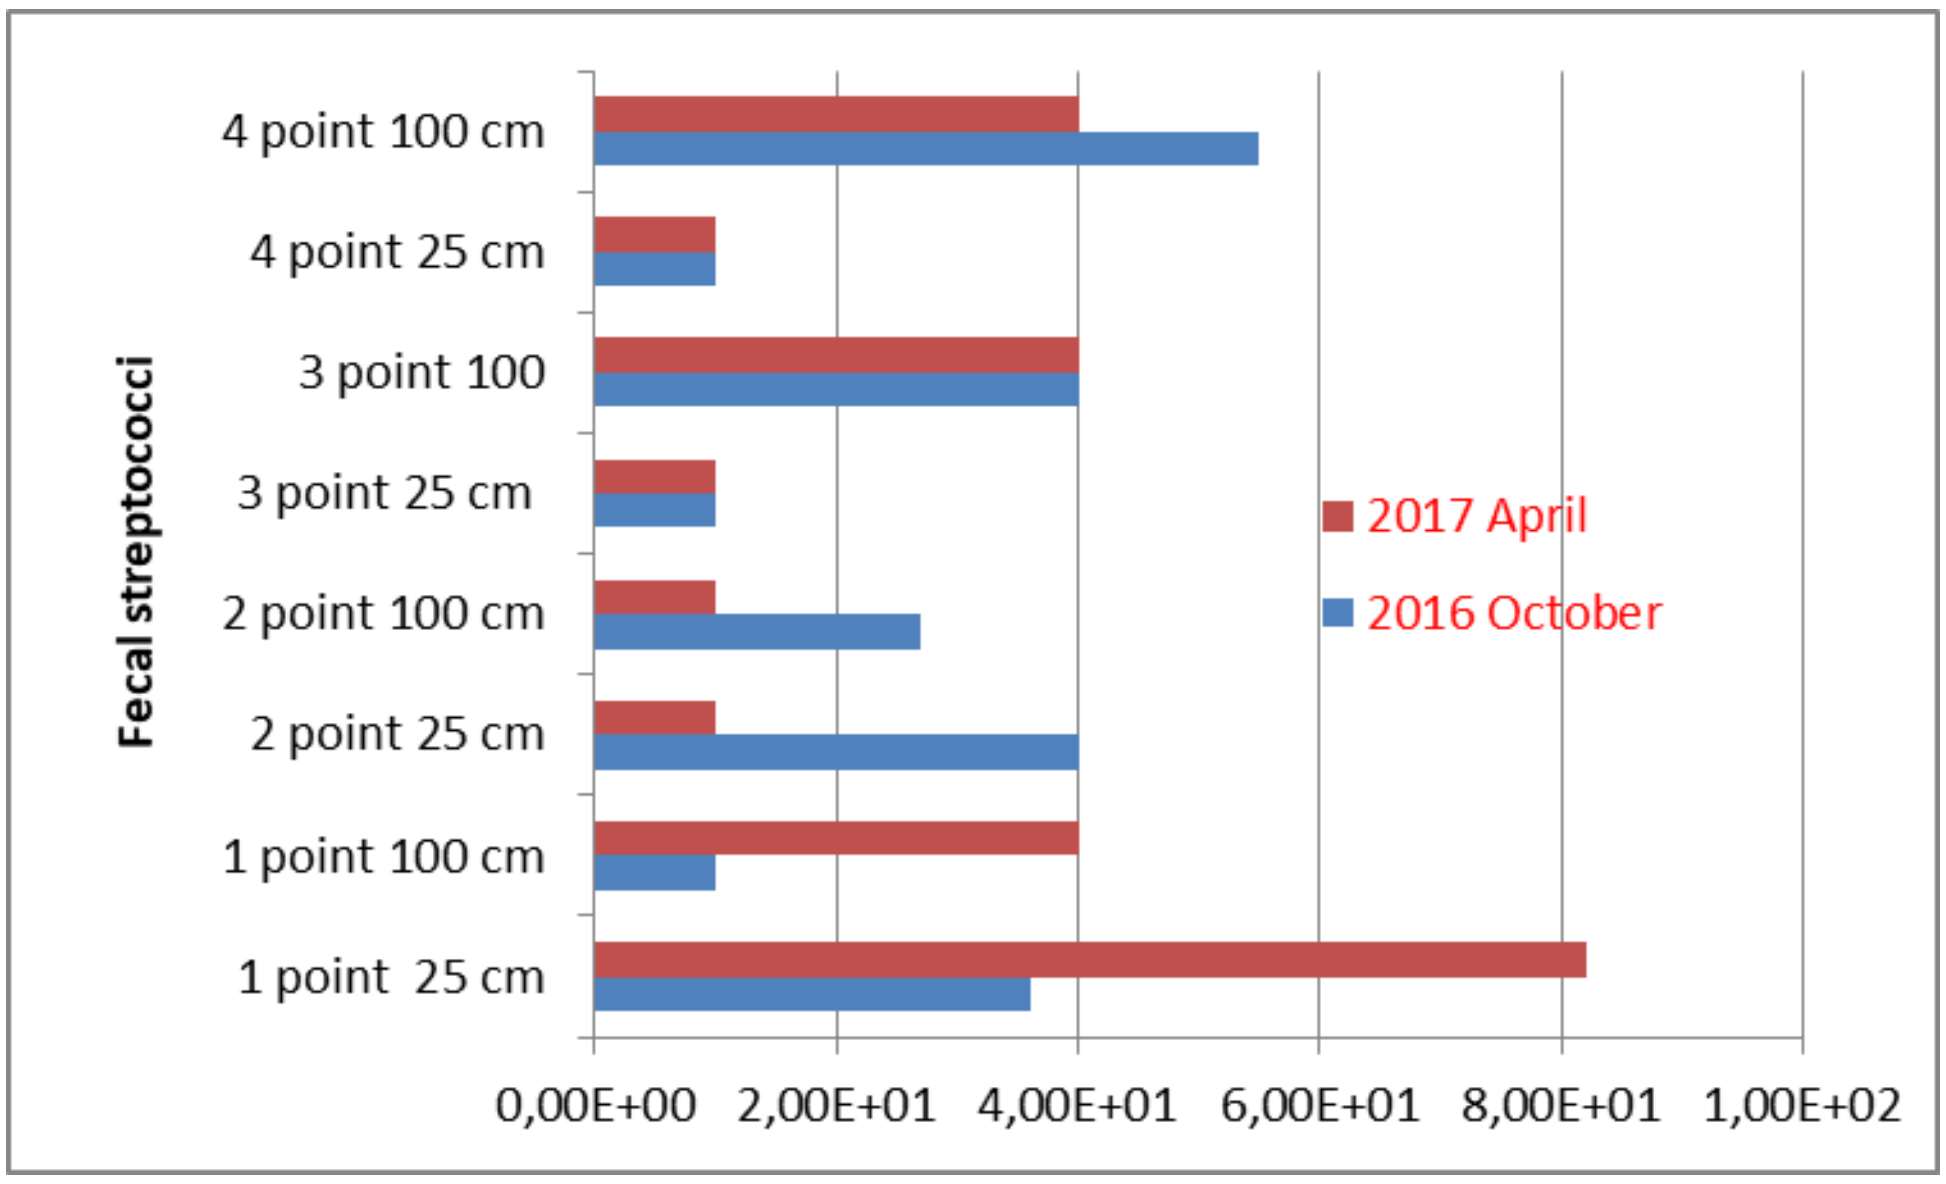
3. 2.1. 19 Figure. Fecal streptococci assessment results 1-4 point 25 and 100 cm depths Soil results

It was found that the Fecal streptococci concentration in points 1 and 2 was higher 25-cm-deep; in points 3 and 4 it was higher in 100-cm-deep soil. It means that in points 3 and 4 the wastewater can have an effect.

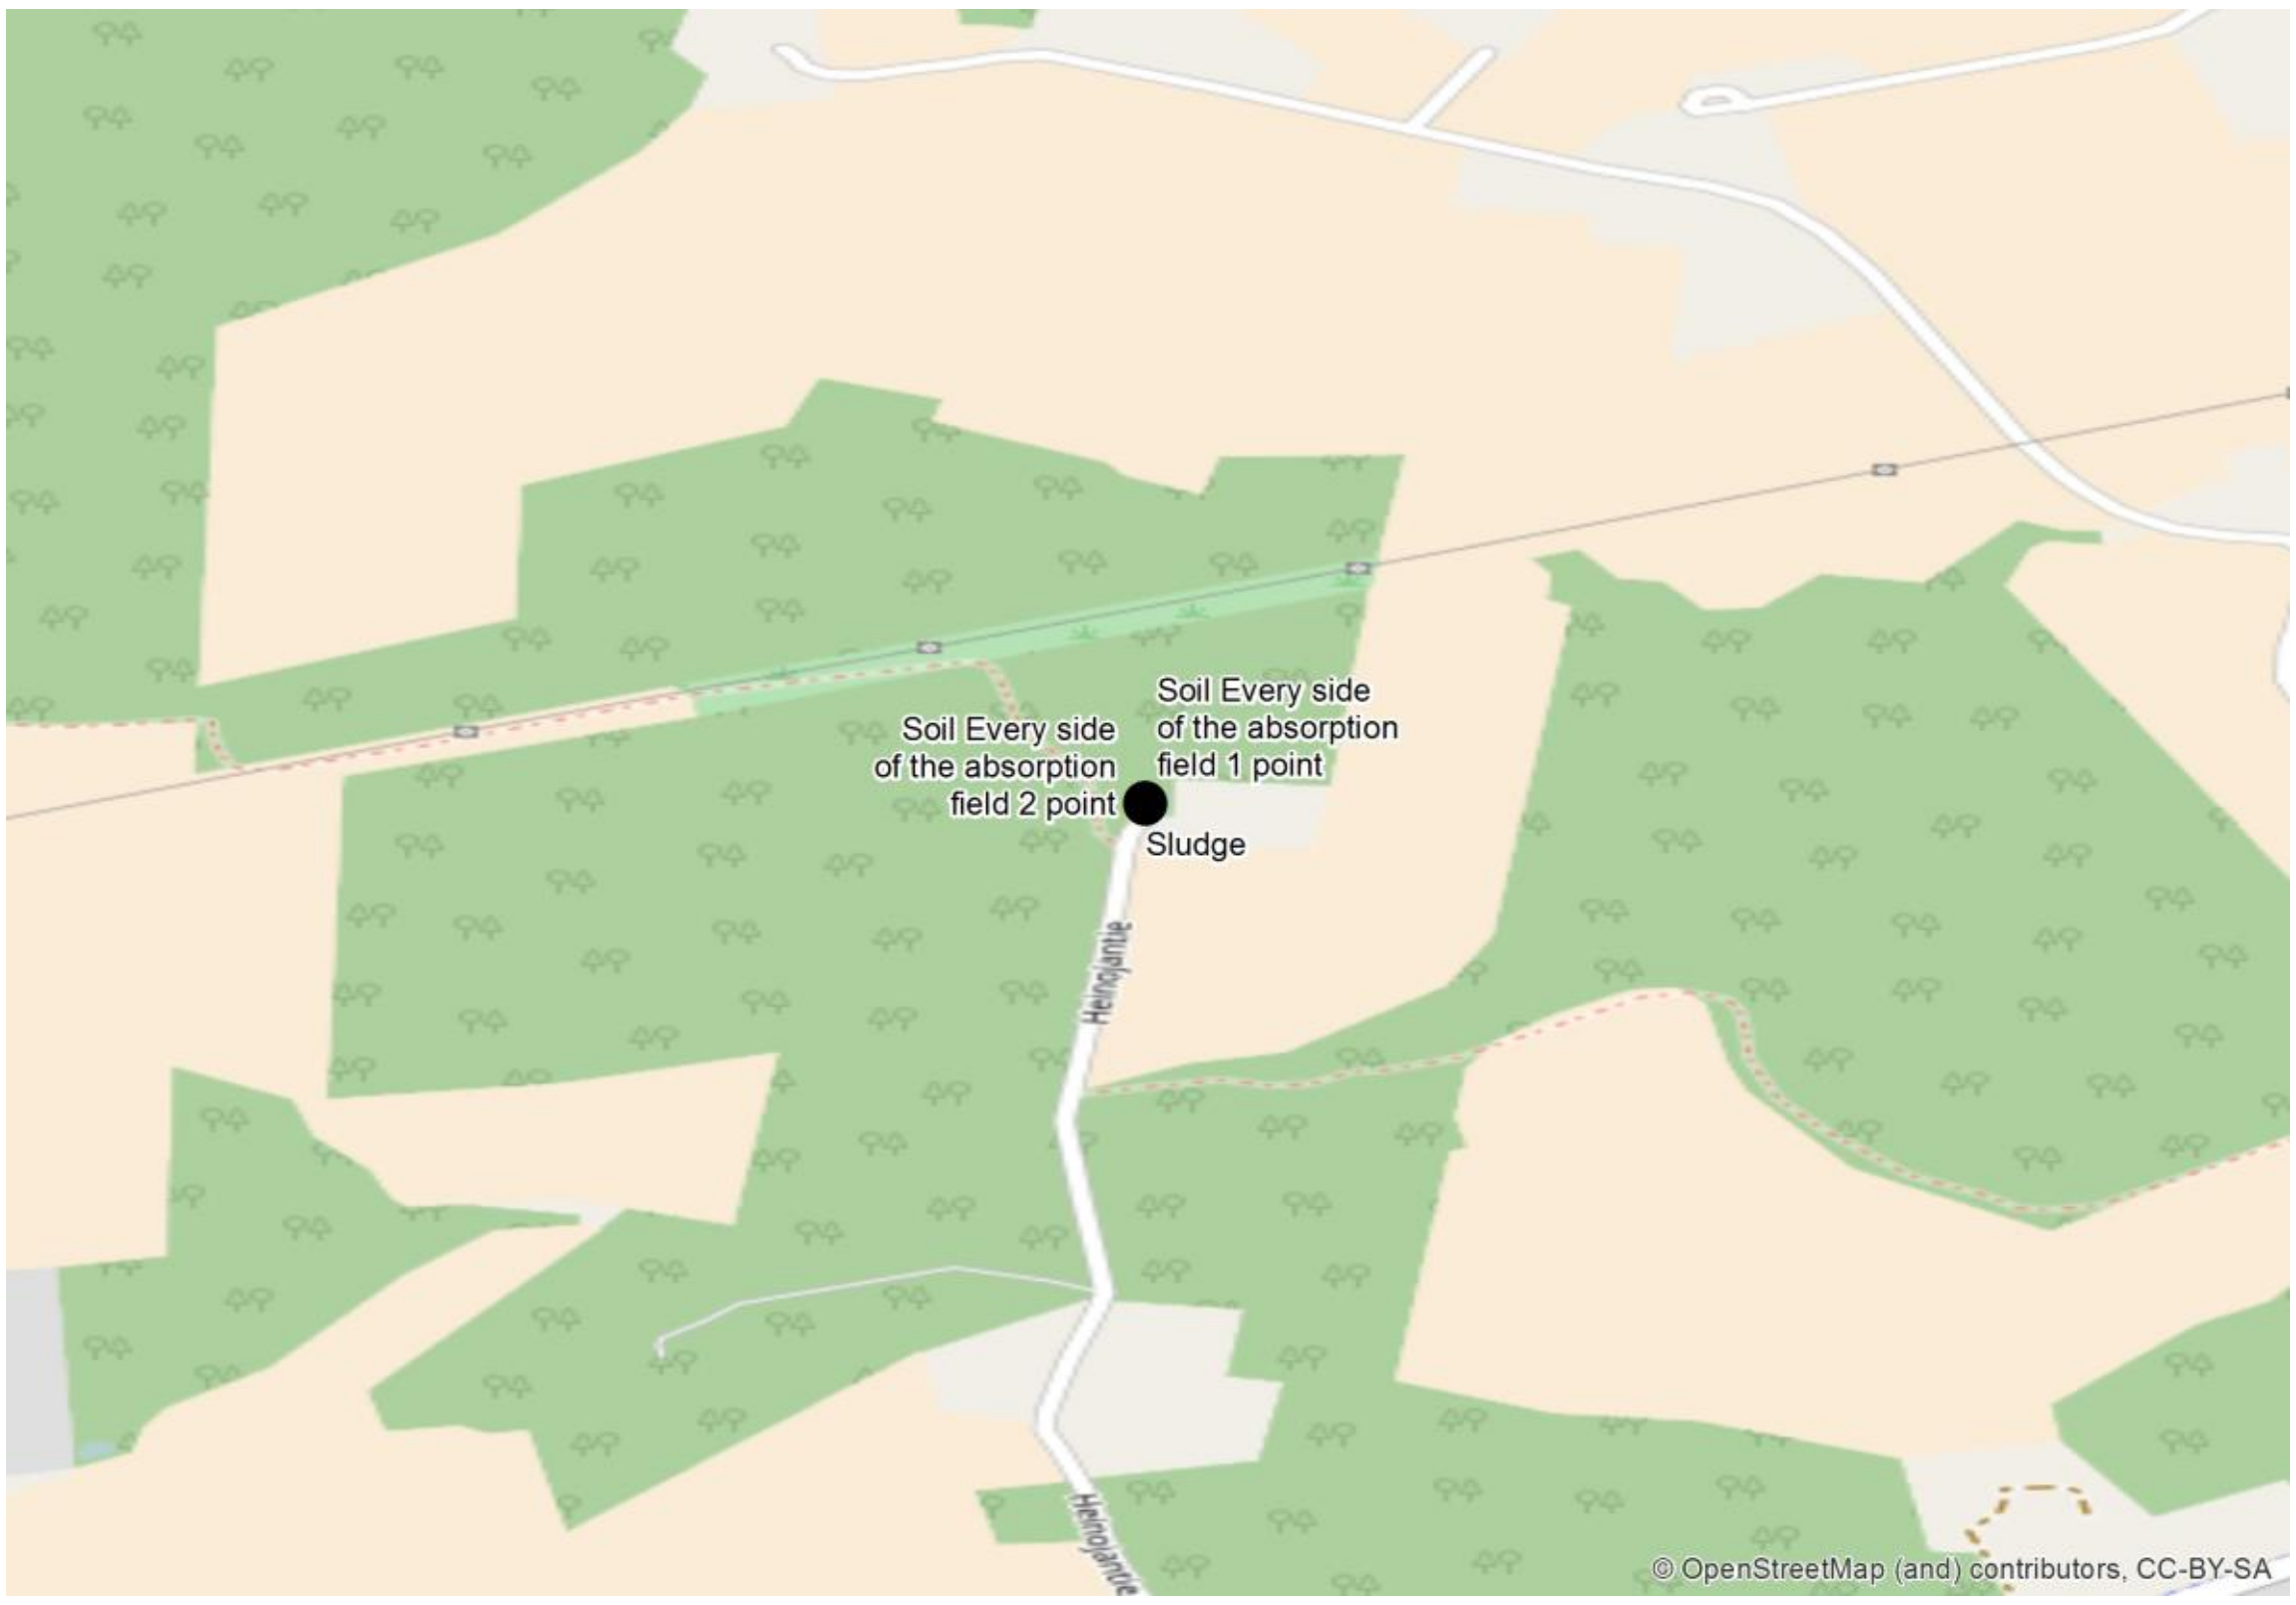
Figure 3.2.2.1. Nurmijärvi

The house is about 300 meters from the nearest houses and the houses do not have the possibility to make a joint wastewater treatment system. The old treatment system, soil filtration with pump has been clogged and the intention is to make similar system next to the old one. The principle of the system is to lift the waste water from the septic tanks through a pump to higher, so that after the filtering field the waters can be discharged to the nearby ditch. Table 3.2.2.1 shows the nutrient analyses in the samples taken from the sewage, sludge, clarification tank and end of outlet of the soil filtrated waste water.

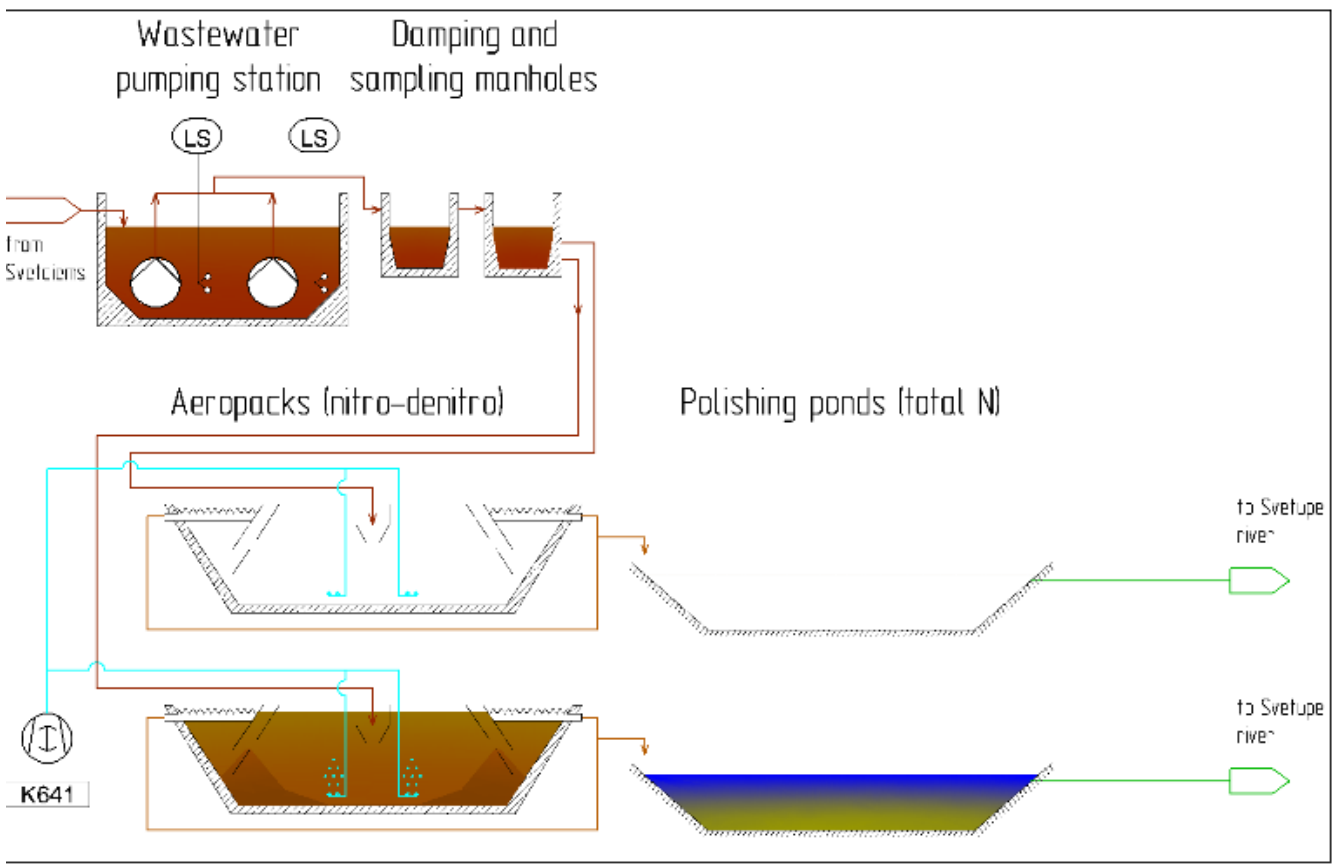
Figure 3.3.1.3. Operation of existing WWT plant.

Problems to be solved. The projected capacity are too large for currently produced wastewater loads. Therefore only one aero-tank is operated;

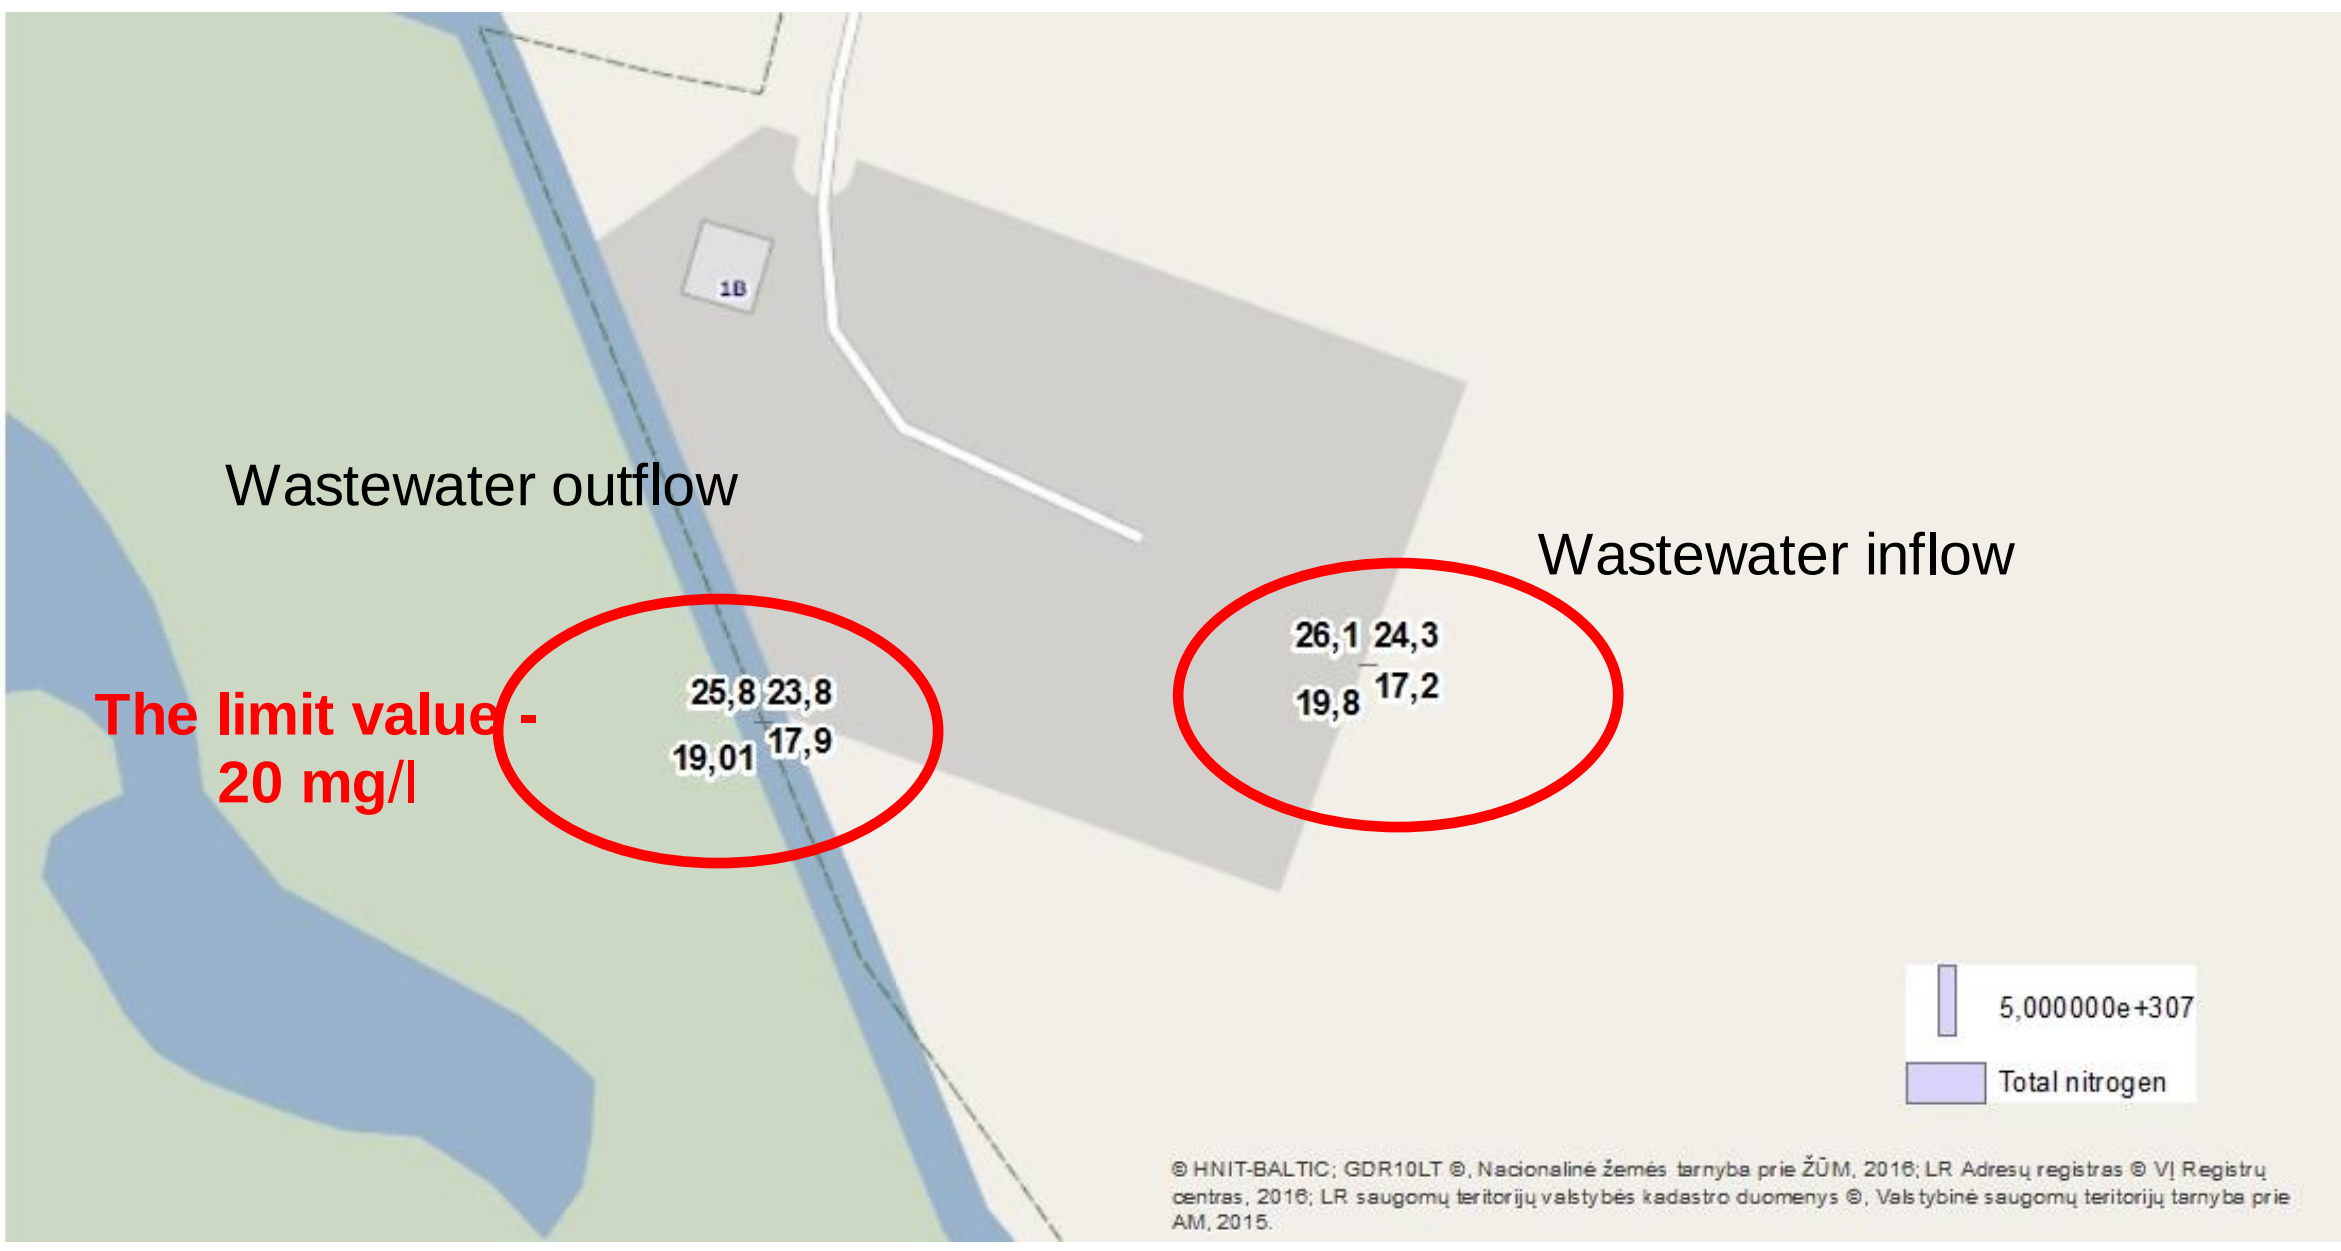
Figure 3.4.2. The concentrations of total nitrogen in the inflowing untreated and outflowing treated wastewater in Leitgiriai

The results in the tables illustrate the existence of wastewater treatment problems: Leitgiriai WWTP seasonal uses only periodical operation ditch with mechanical aeration, it does not provide adequate wastewater treatment. During the cold season WWTP stops working because of inability of mechanical aerators to use in freezing temperature.

The results have shown that during the treatment process the wastewater is treated inefficiently and vary: submerged materials 29–47%, biochemical oxygen consumption in 7 days (BOD_7) - 88 -95%, it means that the BDS_7 value in the released wastewater is higher than that in the inflowing wastewater; total nitrogen (N_t) –4 - 46%, total phosphorus (P_t) 2- 86 %. During the assessment it was found that the treatment of total nitrogen and ammonium nitrogen has changed the most (%).

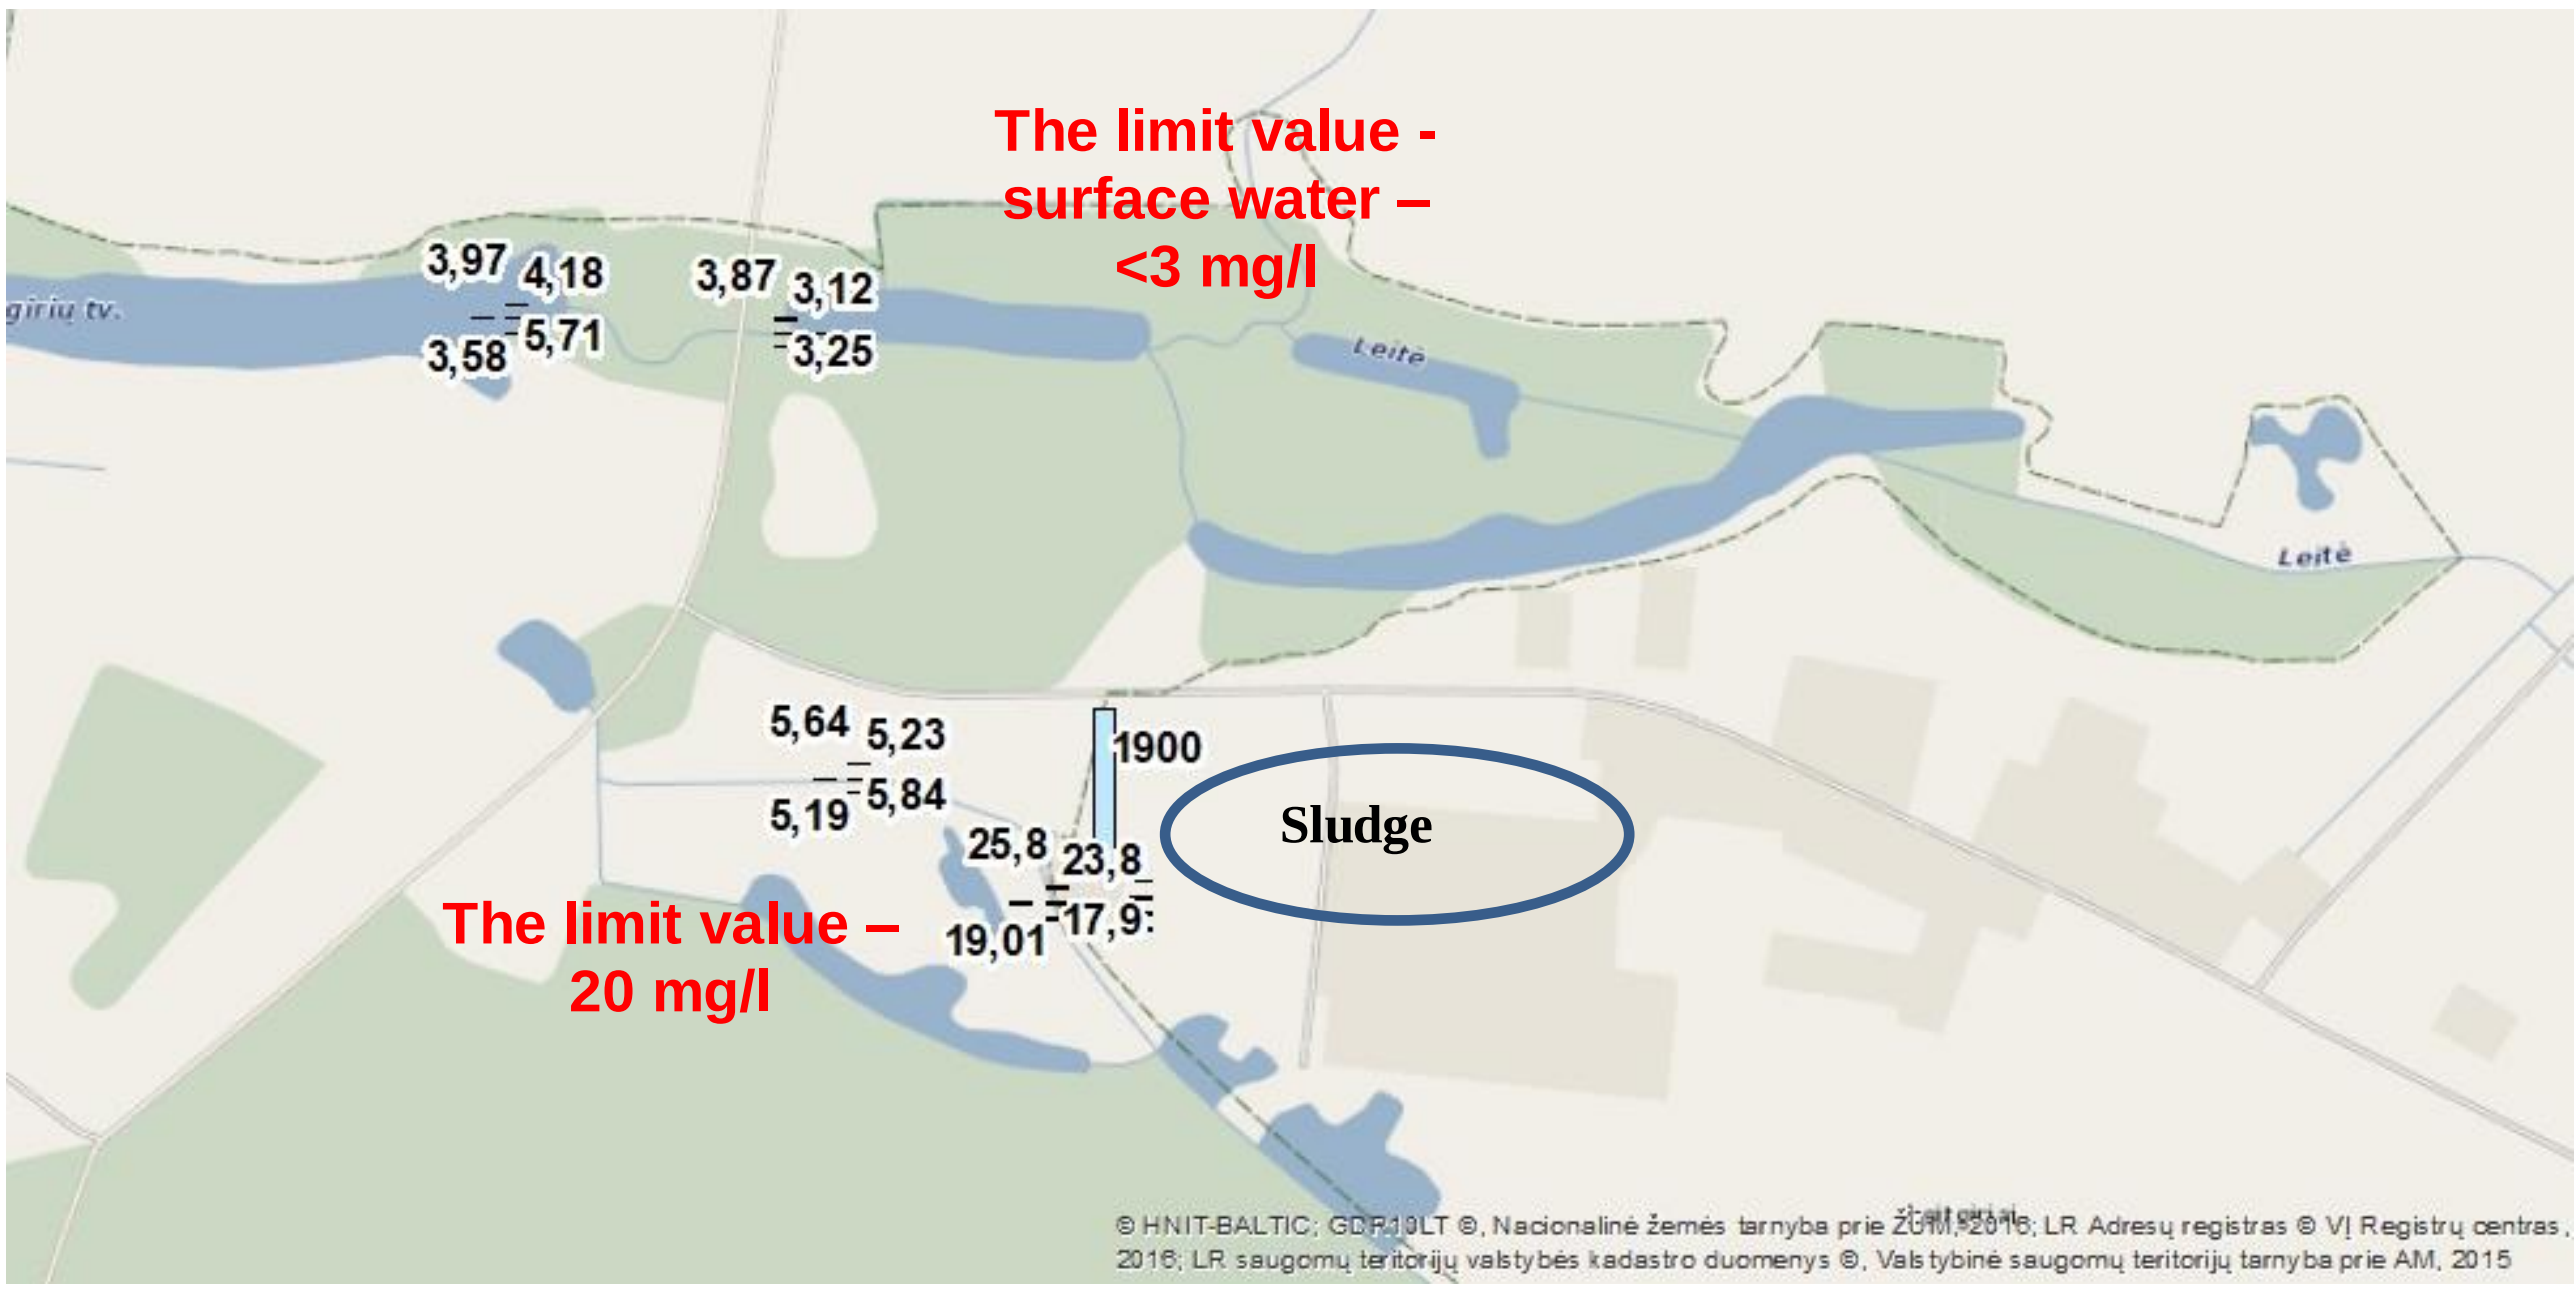
The data provided in the tables shows that the Leitė creek's condition is bad according to the nitrogen concentration, nitrate nitrogen concentration and ammonium nitrogen concentration both before and after the wastewater discharger in all assessment cases. The total nitrogen and total phosphorus concentrations in the wastewater and surface water are shown in Figures 3.4.3 and 3.4.4.

Figure 3.4.3. Total nitrogen concentrations in the wastewater and surface water
