The chemical and microbiological assessment of water and soil samples

FINDING THE BEST FITTING SOLUTIONS FOR WASTEWATER MANAGEMENT IN VILLAGES

VillageWaters Project
Research about Wastewater Treatment Systems

Report number 1

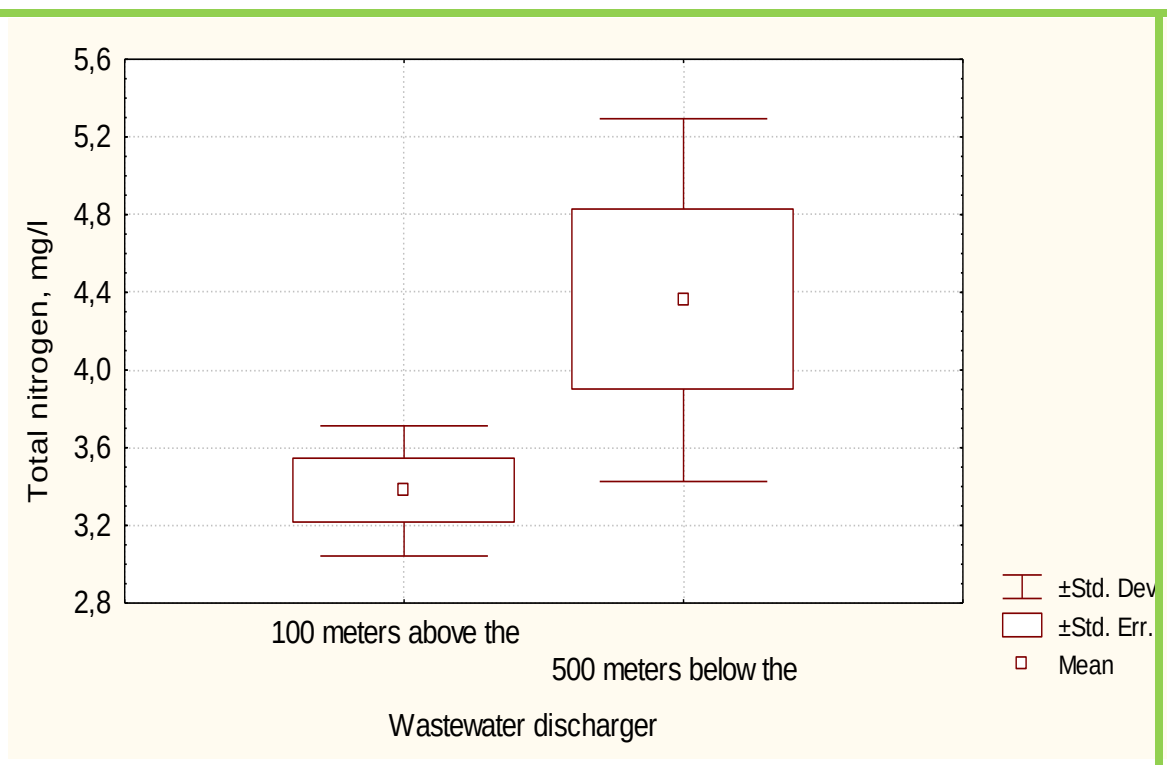
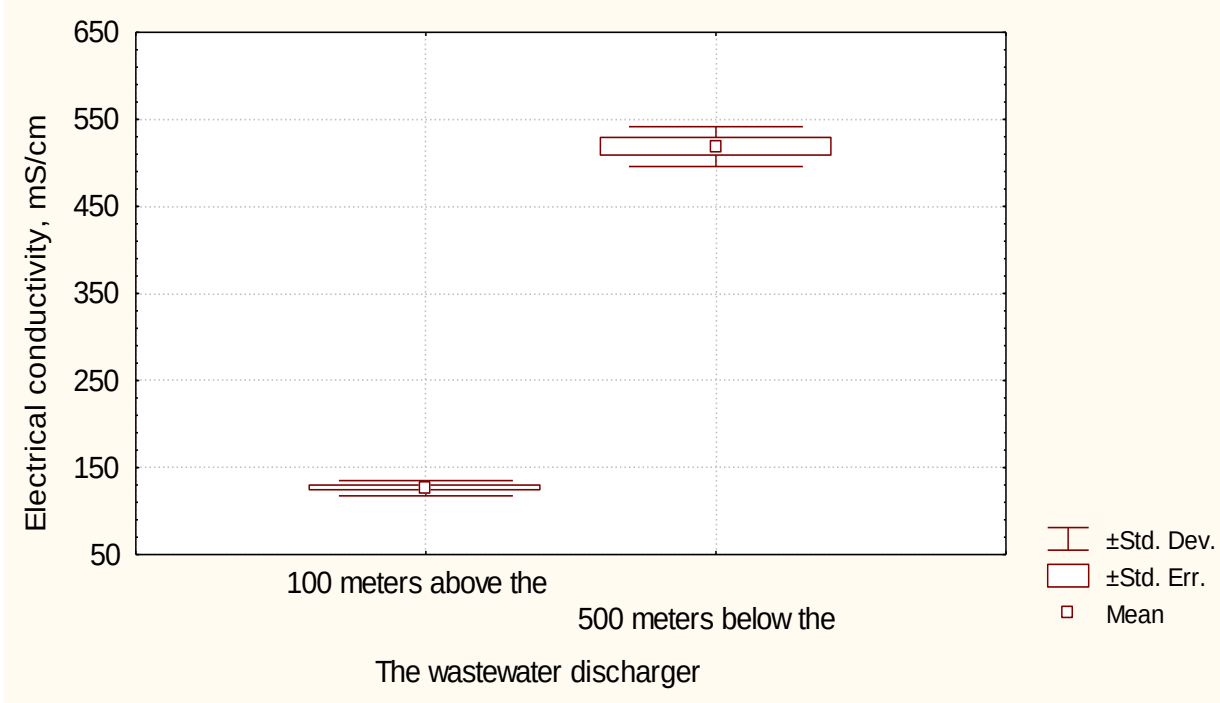
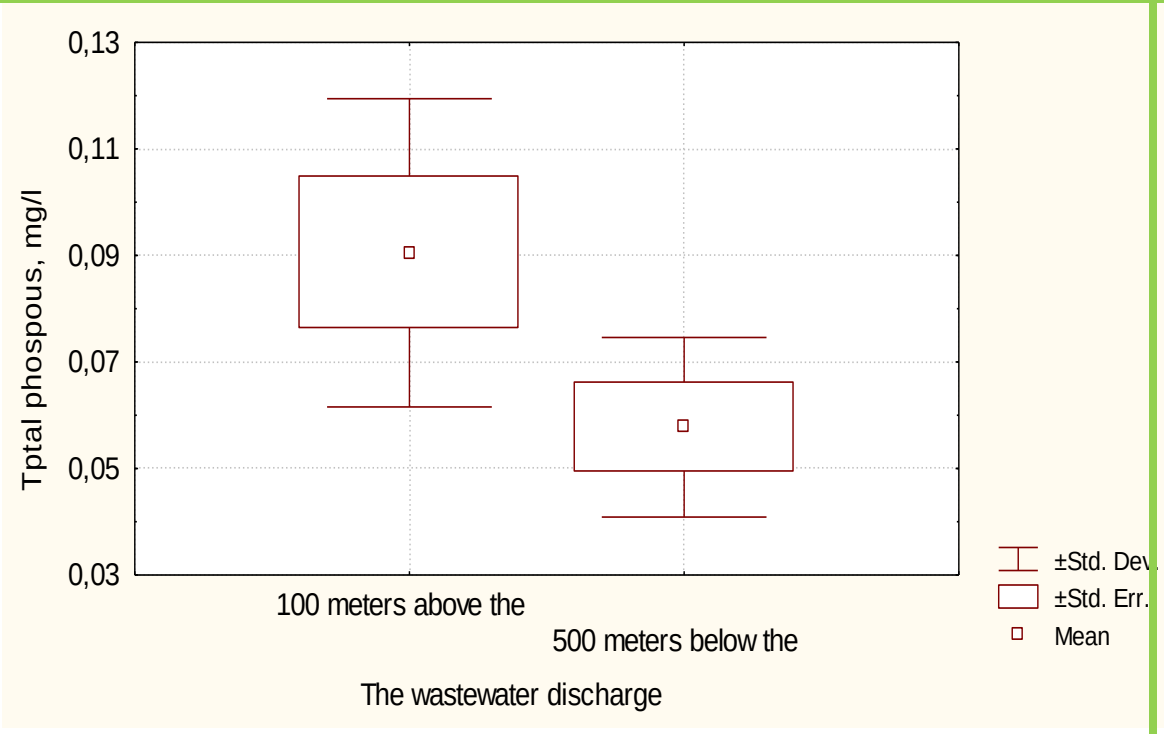
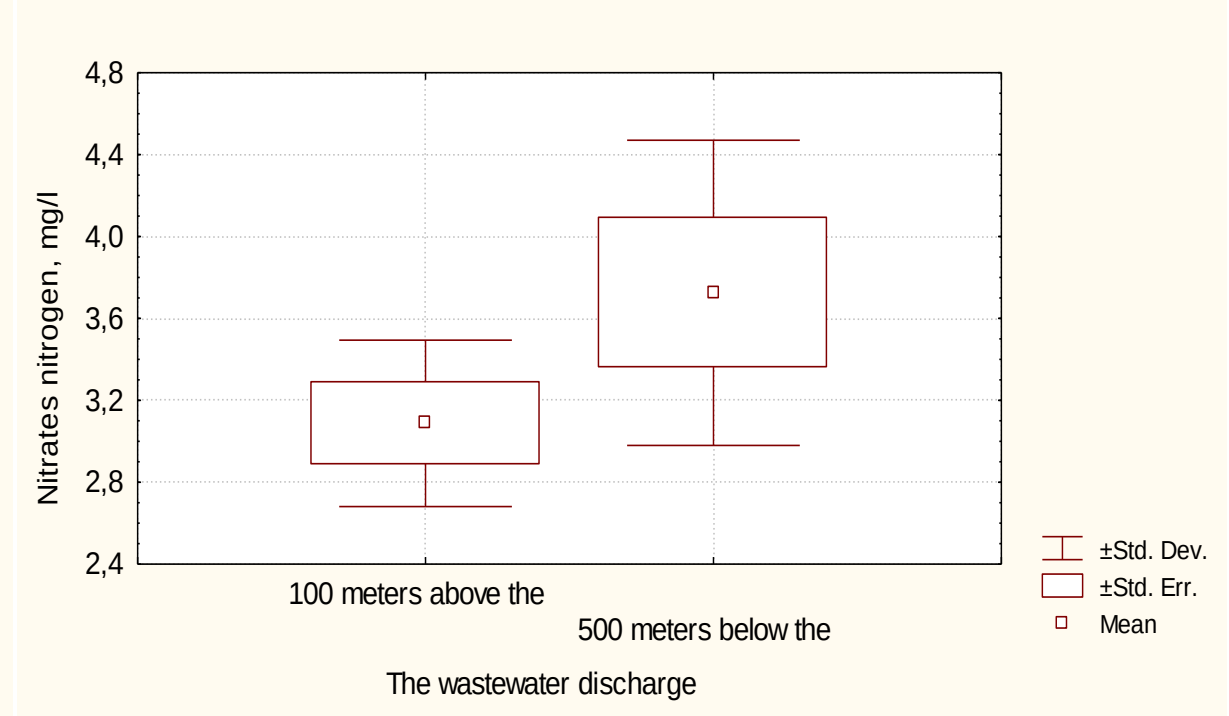
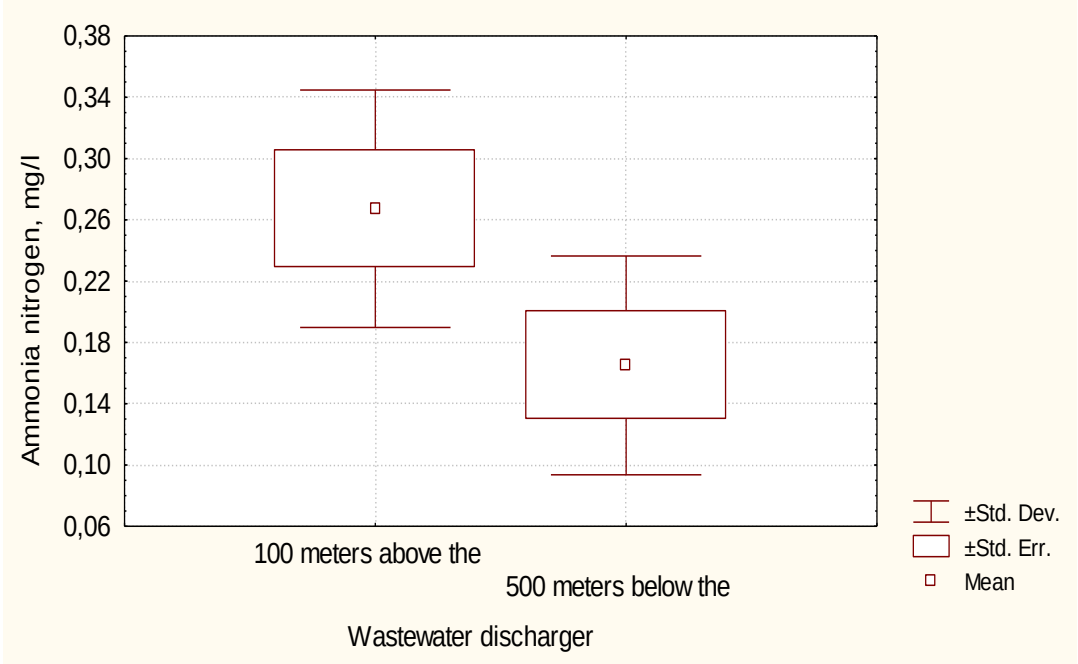
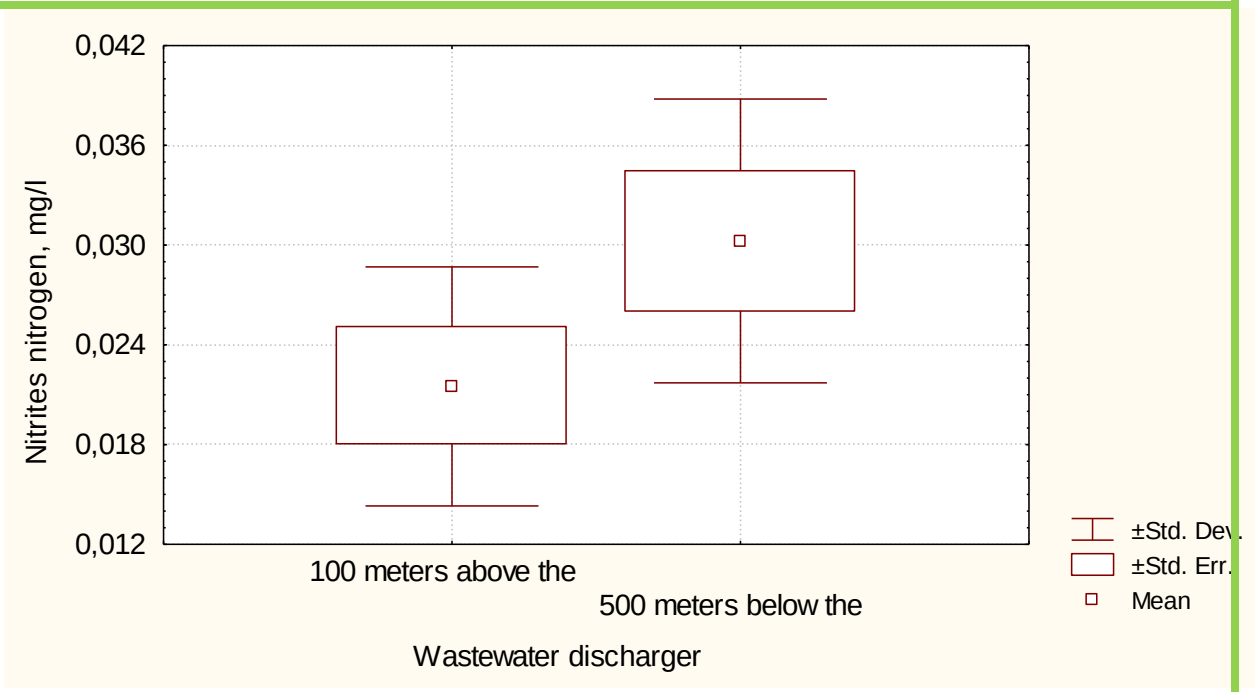
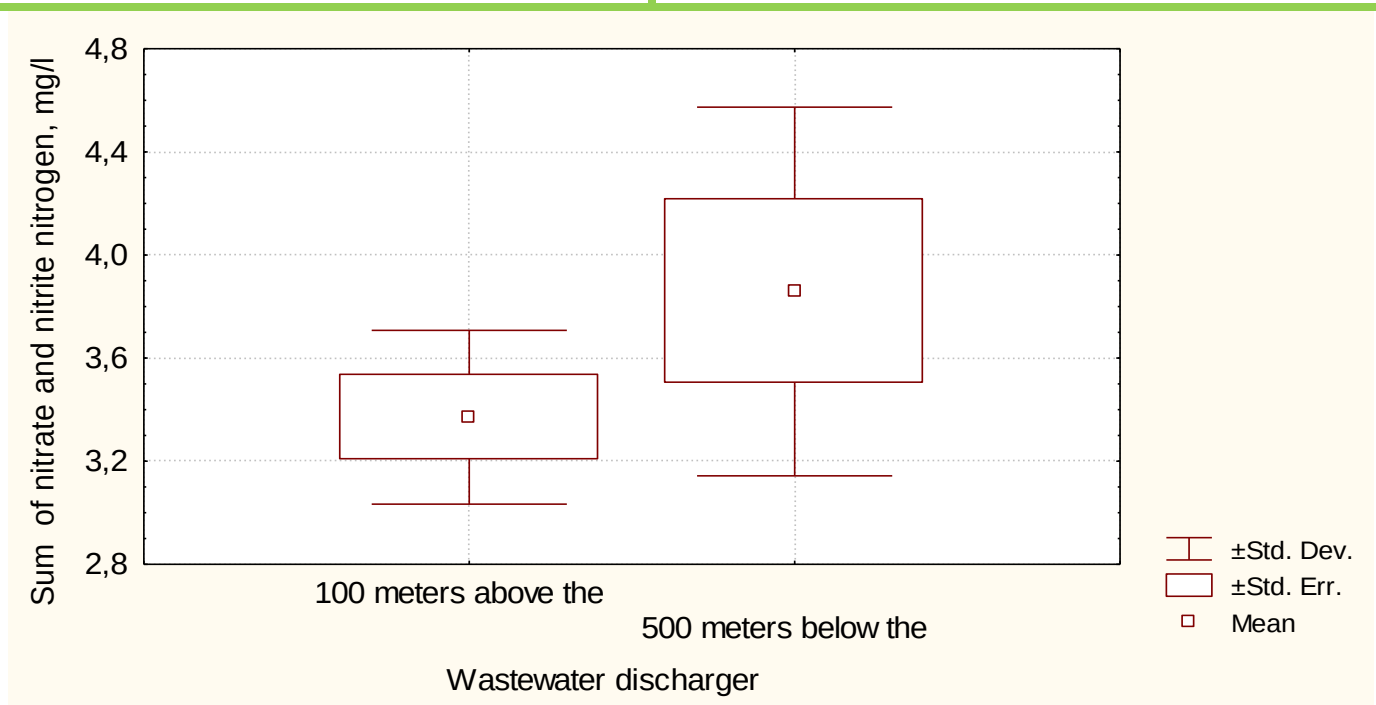
Figure 3.4.5. Water-quality indicator values in the Leitė creek 100 m before and 500 m after the wastewater discharger

It was found that the values of nitrate nitrogen, total nitrogen, electrical conductivity were statistically significantly higher 500 m after the wastewater discharger than 100 m before the wastewater discharger. The differences between the ammonium nitrogen and total phosphorus concentrations were not significant.
